## **Island 32 Erosion**

prepared for  
Ministry of Environment, Lands and Parks  
10334 152A Street  
Surrey, British Columbia, V3R 7P8

by  
Michael Church and Hamish Weatherly  
Department of Geography  
The University of British Columbia  
Vancouver, British Columbia, V6T 1Z2

November 22, 1999

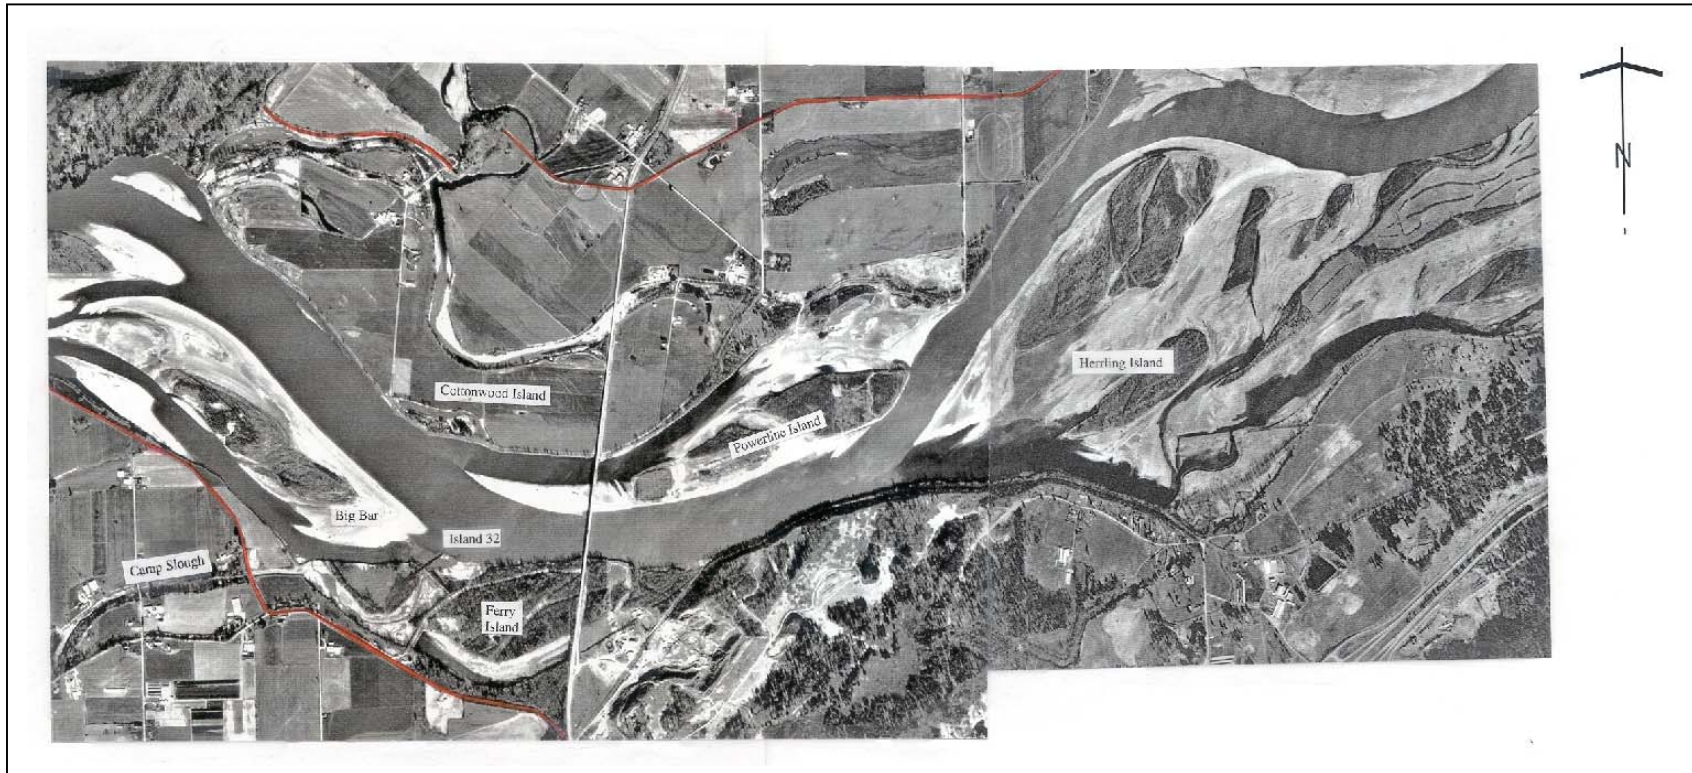
**Figure 1 Island 32 and vicinity, March 20, 1999; Mission flow 699 m<sup>3</sup>/s. Airphoto 15BCB99001-19; source Resource Surveys and Mapping Branch, British Columbia Ministry of Environment, Lands and Parks. Scale is approximately 1:20,000. To facilitate comparisons, a similar scale is maintained for Figures 2 through 8.**

The 1999 photography (Figure 1) was taken at extremely low flows and illustrates the areal extent of Big Bar and the bar at the tail end of Powerline Island. Erosion continued to occur along the north bank of Island 32 during the 1990's, trimming the bank so that is parallel with the bank of Ferry Island.

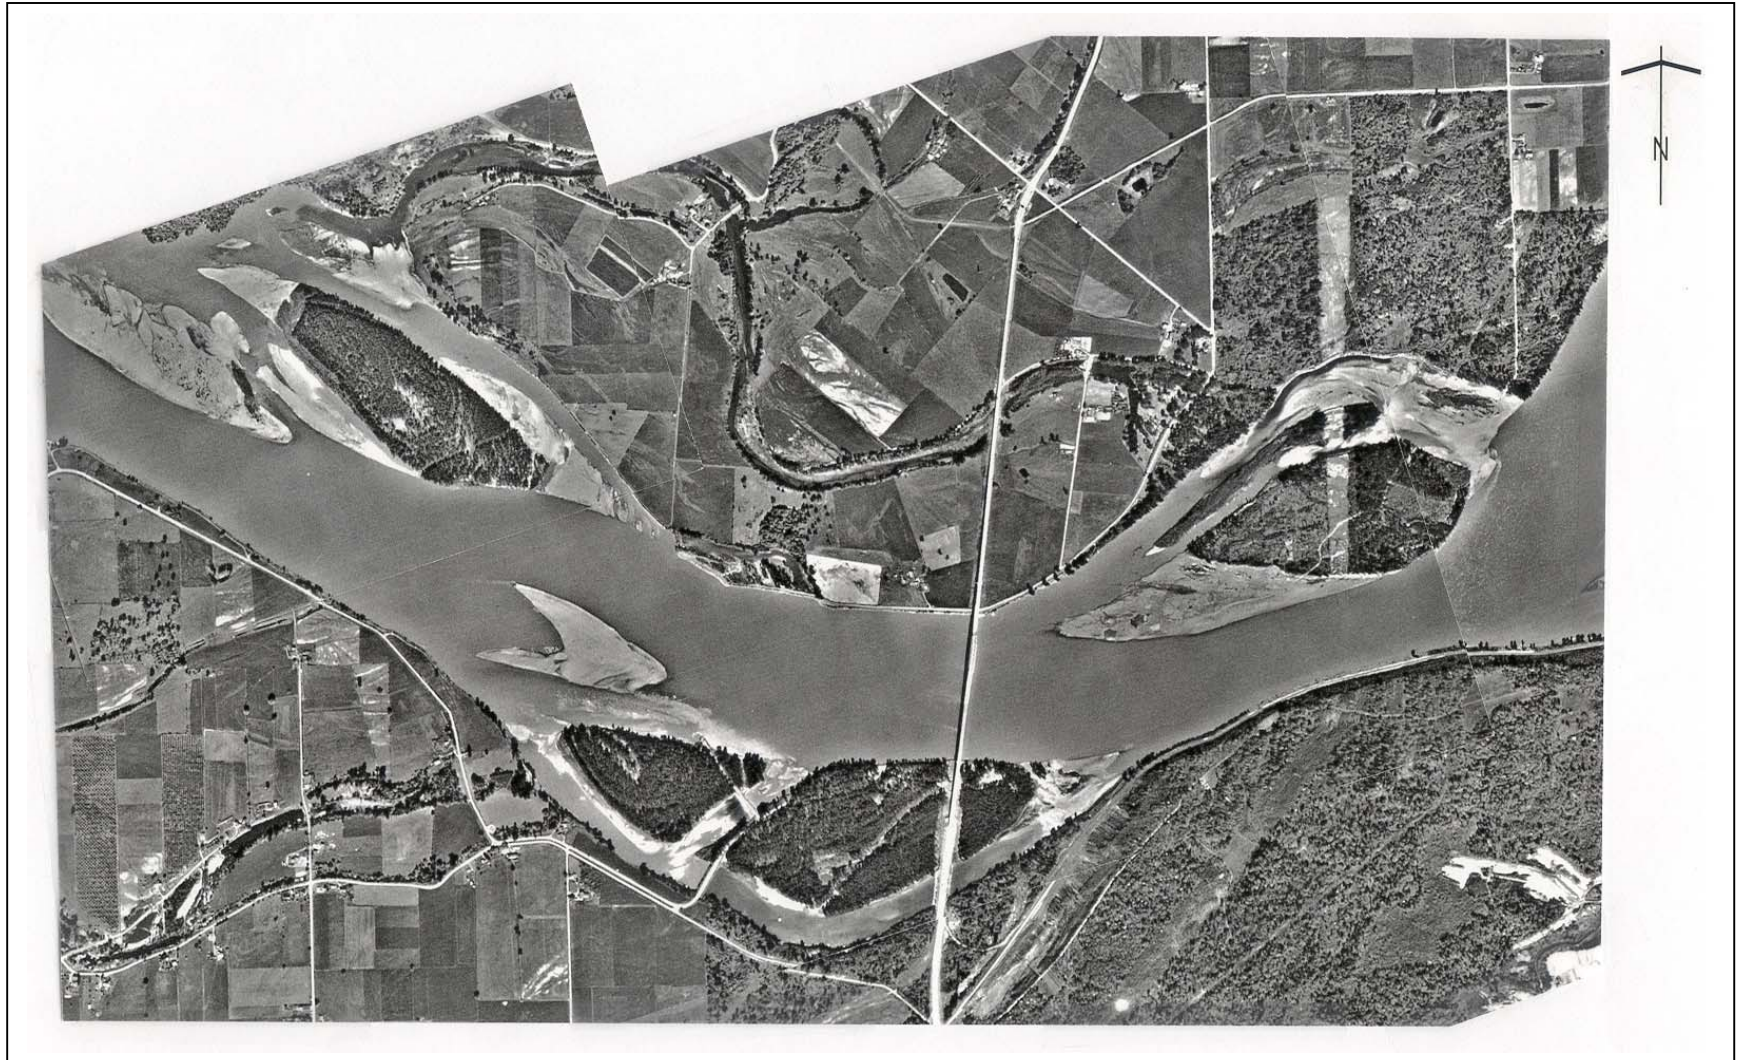
Between 1949 and 1962 (Figure 5), the river continued to shift to the right opposite lower Herrling Island, causing erosion that trimmed the shore along upper Powerline Island. The main channel continued to be confined to the left side and the large bar off Ferry Island had moved downstream and appears to have been considerably reduced (although flow stage in the successive airphotos makes strict comparison difficult). The remains of the bar were located off the downstream end of Island 32, as shown on Figure 5. In addition, the entrance to the Ferry Island back channel had begun to silt up.

**Figure 5 Island 32 and vicinity, May 7, 1962; Hope flow 2,940 m<sup>3</sup>/s. Airphotos BC5042-100, 101; source Resource Surveys and Mapping Branch, British Columbia Ministry of Environment, Lands and Parks.**

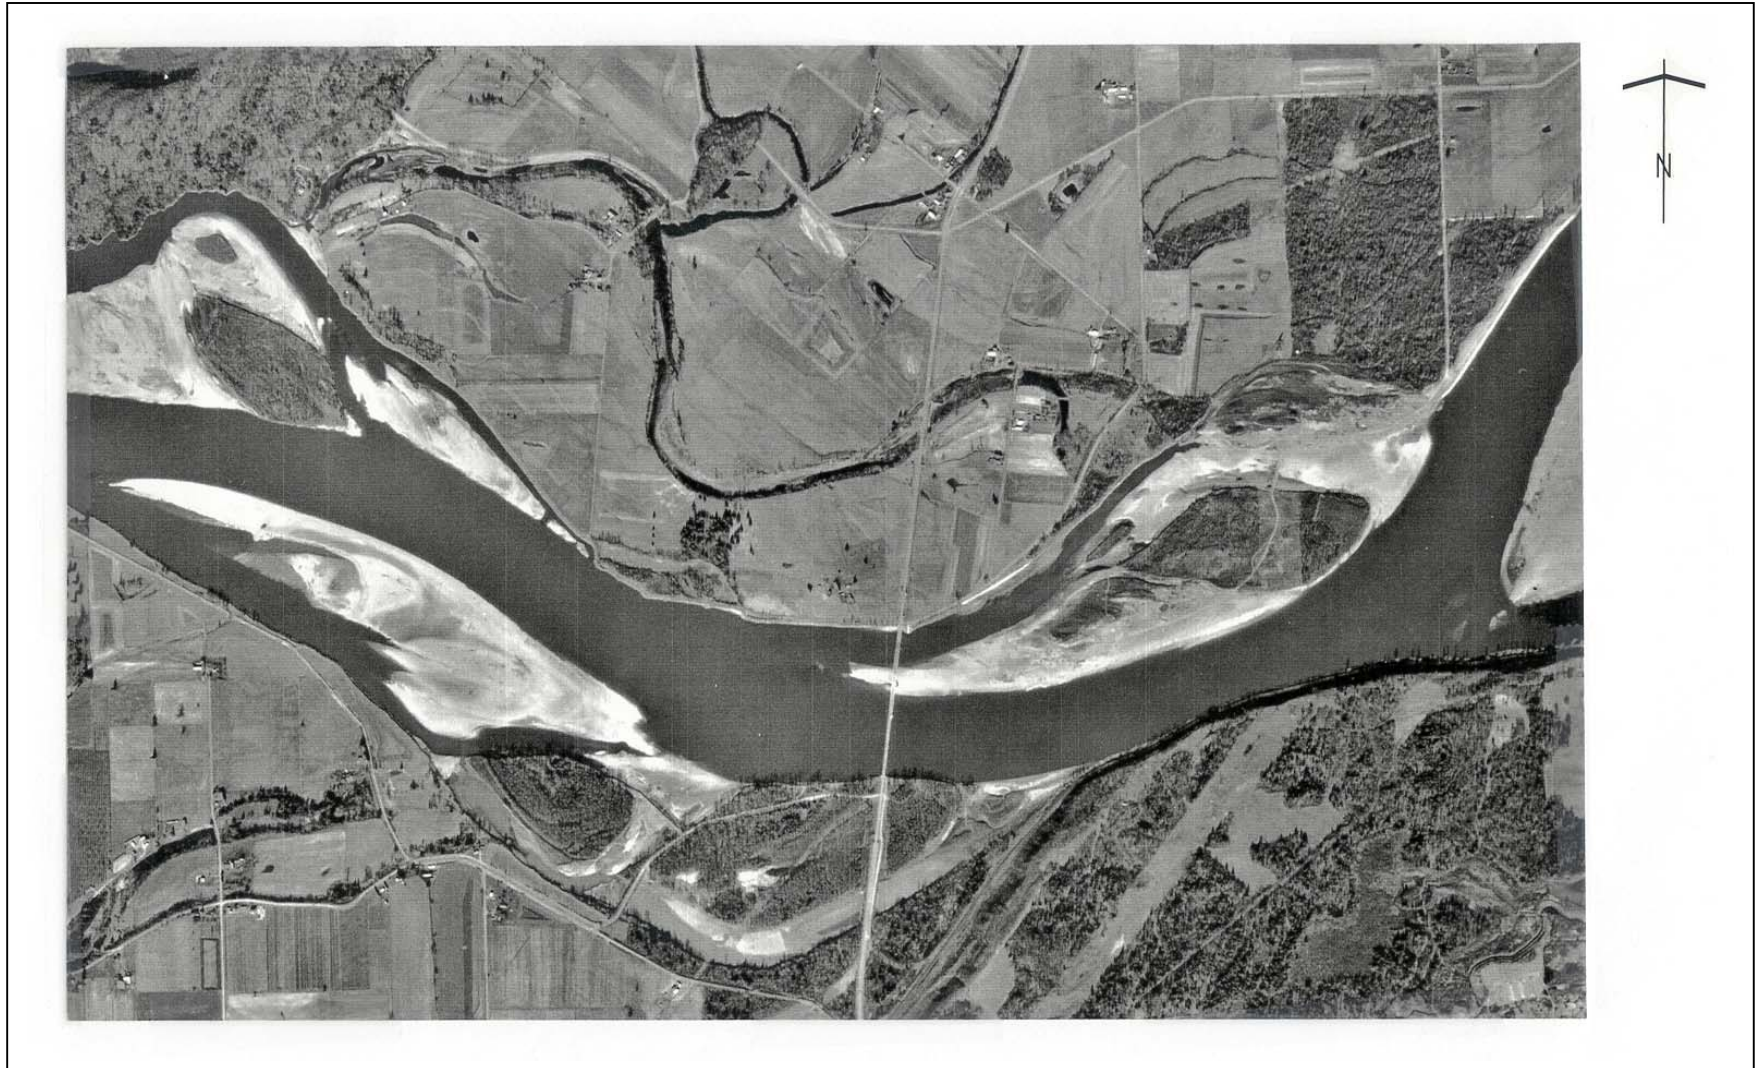
By 1971, the Ferry Island backchannel was largely inactive and had a much reduced conveyance capacity (Figure 6). This increased the high stage constriction of flow in the main channel. Bar growth continued at the downstream end of both Powerline Island and Island 32, beginning the development of Big Bar. A small upstream portion of Island 32 was also eroded during this period indicating that high flows were spilling through the channel between Ferry Island and Island 32.

**Figure 6 Island 32 and vicinity, March 19, 1971; Hope flow 799 m<sup>3</sup>/s. Airphotos BC5046-150; source Resource Surveys and Mapping Branch, British Columbia Ministry of Environment, Lands and Parks.**

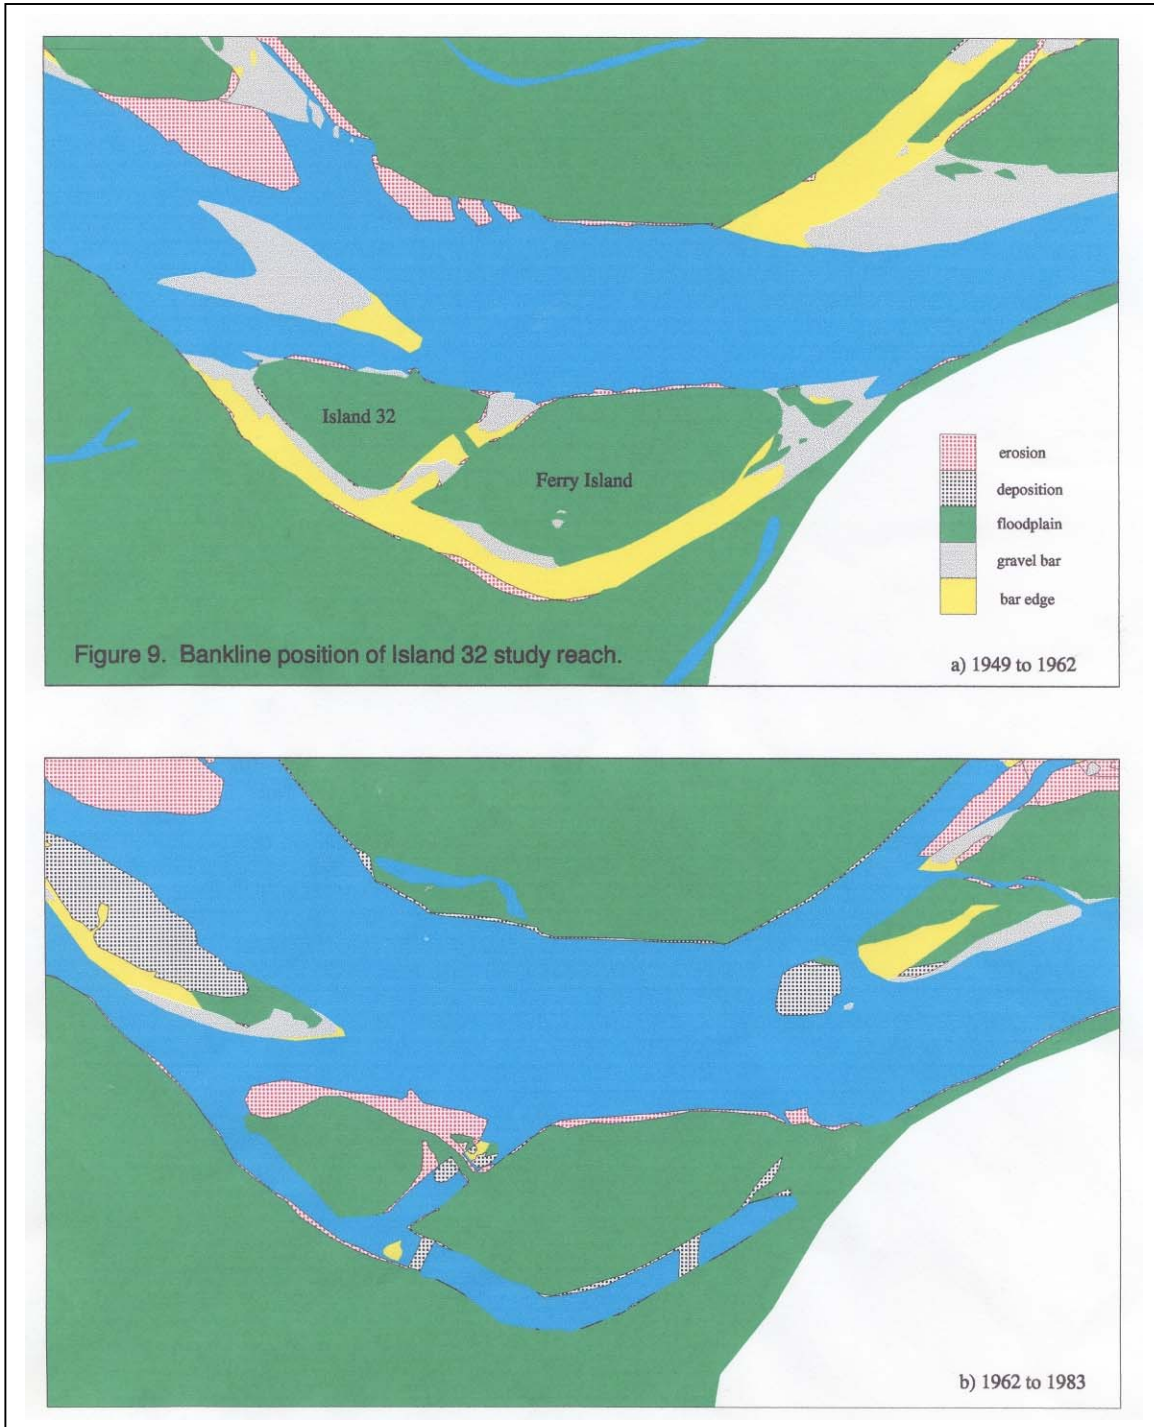
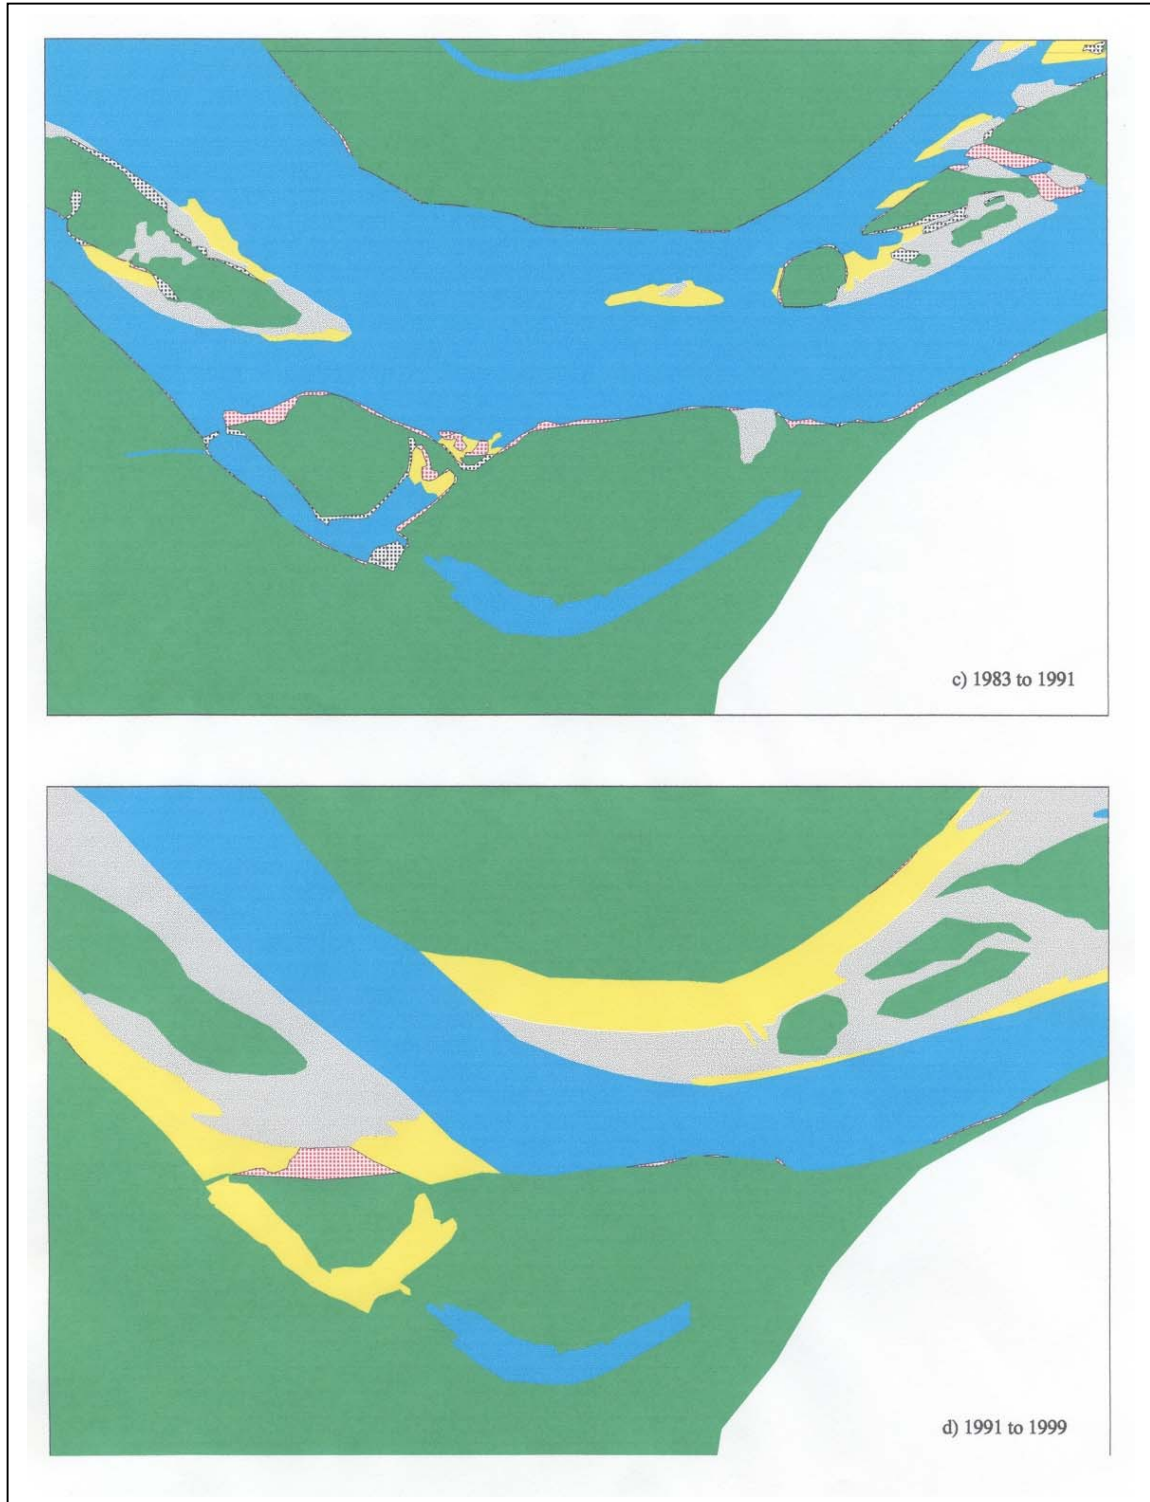
Figure 9 Bankline position of Island 32 study reach: a) 1949 to 1962, b) 1962 to 1983, c) 1983 to 1991, and d) 1991 to 1999.

The changes described above can be assessed quantitatively by using historic channel maps of channel bar, island and bankline positions. By digitizing airphotos for the gravel reach of Fraser River, channel maps for 1949, 1962, 1983, 1991 and 1999 have been created at the Geography Department of University of British Columbia. Bankline positions from these years for Island 32 have been plotted on Figures 9a to 9d (Figure 9). Erosion of the north bank of Island 32 between these dates is as follows:

The more active erosion following 1962 is a product of the main flow becoming increasingly confined to the left side. Some erosion has also occurred along the bank of Ferry Island within this time period, but extensive armoring of the banks has limited loss of land. The most active period has occurred within the past eight years.

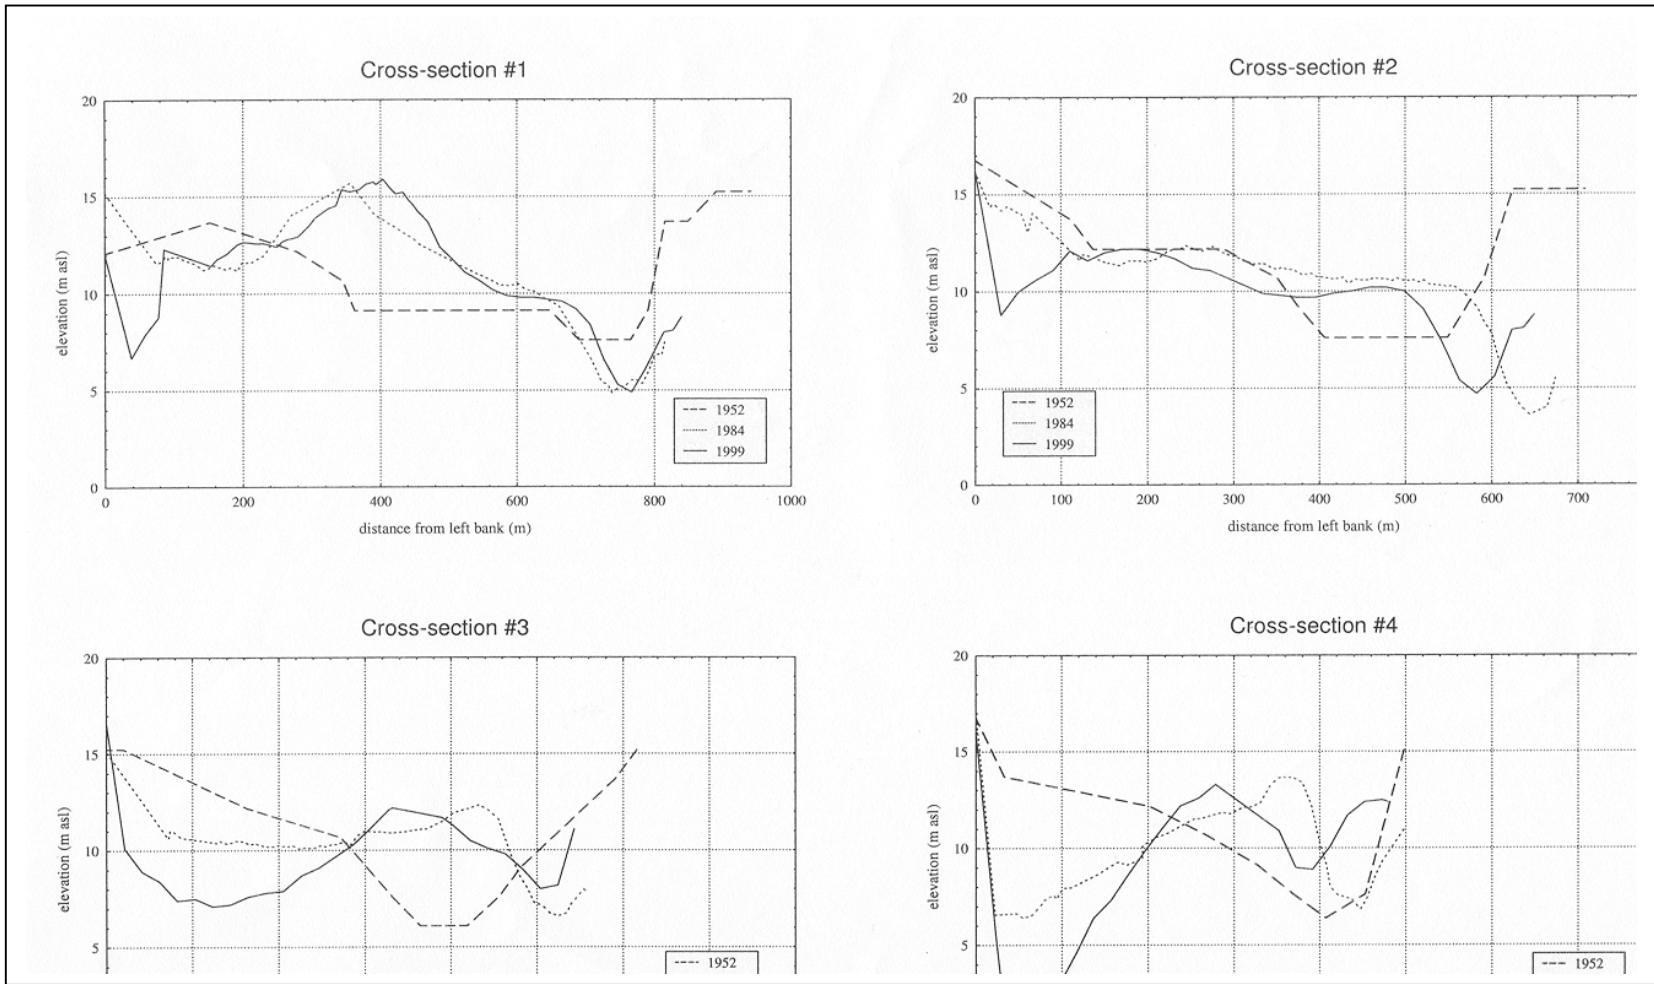
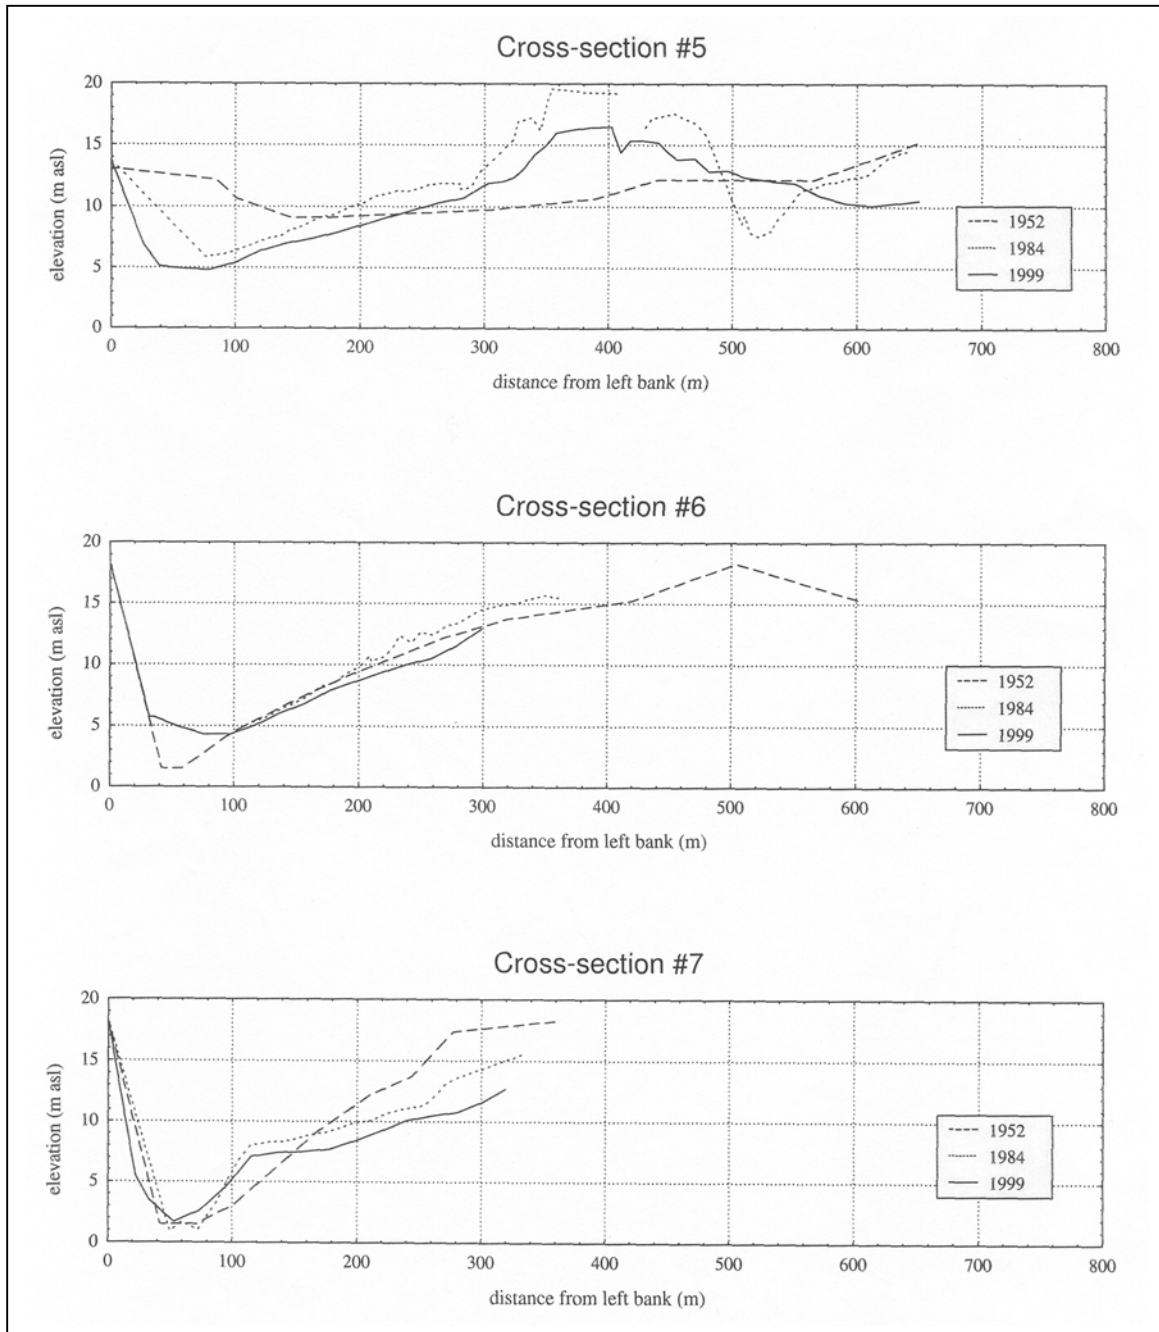
Figure 11 Cross-sections through Island 32 study reach.

study area (Figure 10) have been constructed from these bathymetric surveys and are shown in Figure 11. Since 1952, there have been few changes in the channel geometry at Powerline Island (cross-sections 6 and 7). Further downstream, however, there is an abrupt shift in the thalweg from the right to the left between 1952 and 1984 (cross-sections 3 and 4), and progressive deepening of the channel to the present. These changes are associated with the migration of the “Ferry Island bar” downstream into Big Bar, development of the Powerline Island bar, and the consequent channel realignment. Furthermore, the entrance to the Ferry Island back channel silted up in the 1970’s and gravel deposition occurred in the Powerline Island back channel. Reduced flow conveyance in these backchannels has increased the high stage constriction of flow in the main channel. At cross-sections 1 and 2, off Island 32, the thalweg continues to be on the right bank but, following the construction of Big Bar after 1950, the channel remains divided, and there is significant degradation in the left hand channel, which flows between Big Bar and the left bank.

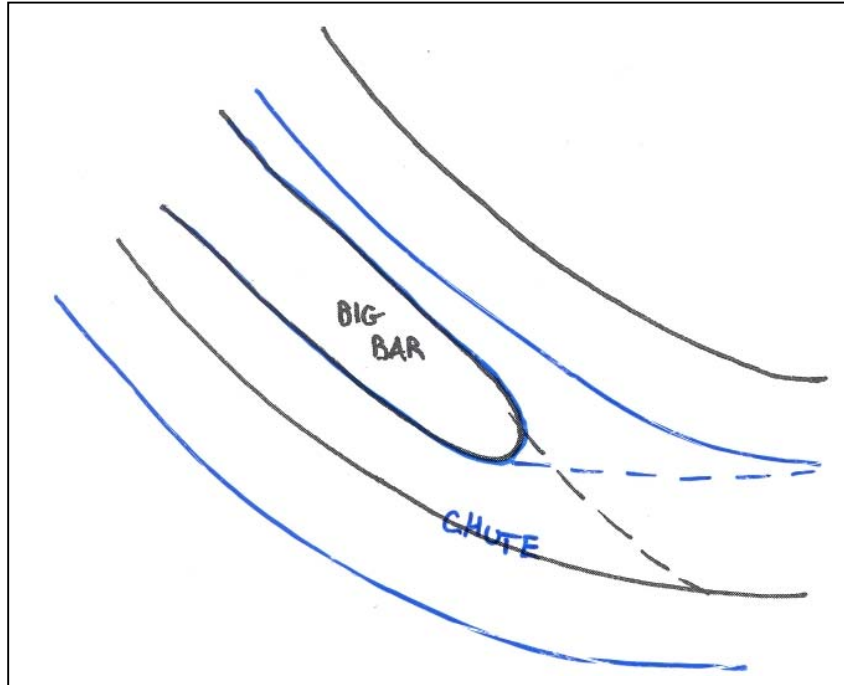
- the deeply-scoured channel upstream is set directly toward the left hand channel;
- in comparison with often observed configurations, the overall configuration of the right-hand bend here suggests that, eventually, a chute will develop at the upstream end of Big Bar, with the majority of the flow moving through the chute and into the left-hand channel (see Figure 12(a and b)).

An alternative scenario would see the main channel of the river continue to cross over to the right bank past Big Bar, with little or no additional sedimentation in the crossover zone. In this case, it is even possible that Big Bar might eventually suture itself to Island 32, although it is not clear where the volumes of sediment required for this might come from (see below). The right-hand bend past Big Bar is not tight, and the river is only slightly narrow through this crossover (425 m between terrestrial vegetation lines, against a desirable width for the full channel of 500 m, the difference being represented by the left-hand channel). A configuration in which the lesser of two channels is on the outside of the bend (as at present) is not unusual along Fraser River (see Figure 12a).

Figure 12a Current (simplified) configuration of channel in vicinity of Island 32 and Big Bar , with the secondary channel on outside of the bend. The potential configuration - secondary channel inside the bend - is overlain in color.

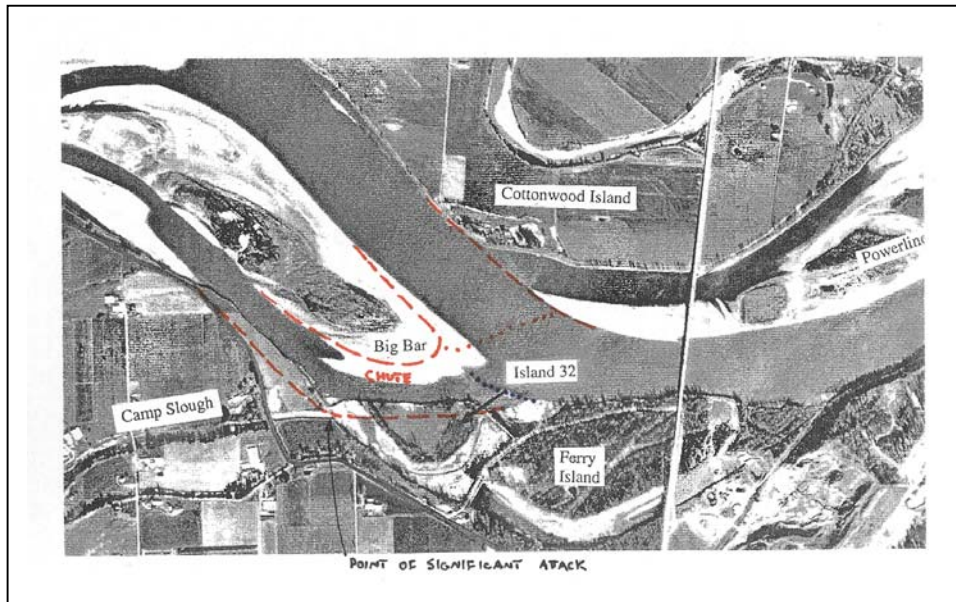
Figure 12 b

In this case, additional sedimentation will occur on the left-hand side of Big Bar and strong flow forces will impinge on the left bank of Fraser River downstream from the corner where Camp Slough takes off. The river would quickly move left and threaten the existing bank revetment (the bank was armoured in the early 1970s). Maximum depths offshore could increase to as much as 15 m below floodplain level. If the bank protection were to become undermined by direct attack, the floodplain might then erode relatively quickly, bringing the river against the main dyke within a few years. The entrance to Camp Slough might also come under attack. However, this is unlikely to lead to uncontrolled flows into the slough, since a gate located at the main dyke controls flows into the slough.
