# **Quaamitch Slough Erosion**

prepared for  
Ministry of Environment, Lands and Parks  
10334 152A Street  
Surrey, British Columbia, V3R 7P8

by  
Hamish Weatherly and Michael Church  
Department of Geography  
The University of British Columbia  
Vancouver, British Columbia, V6T 1Z2

January 30, 2001

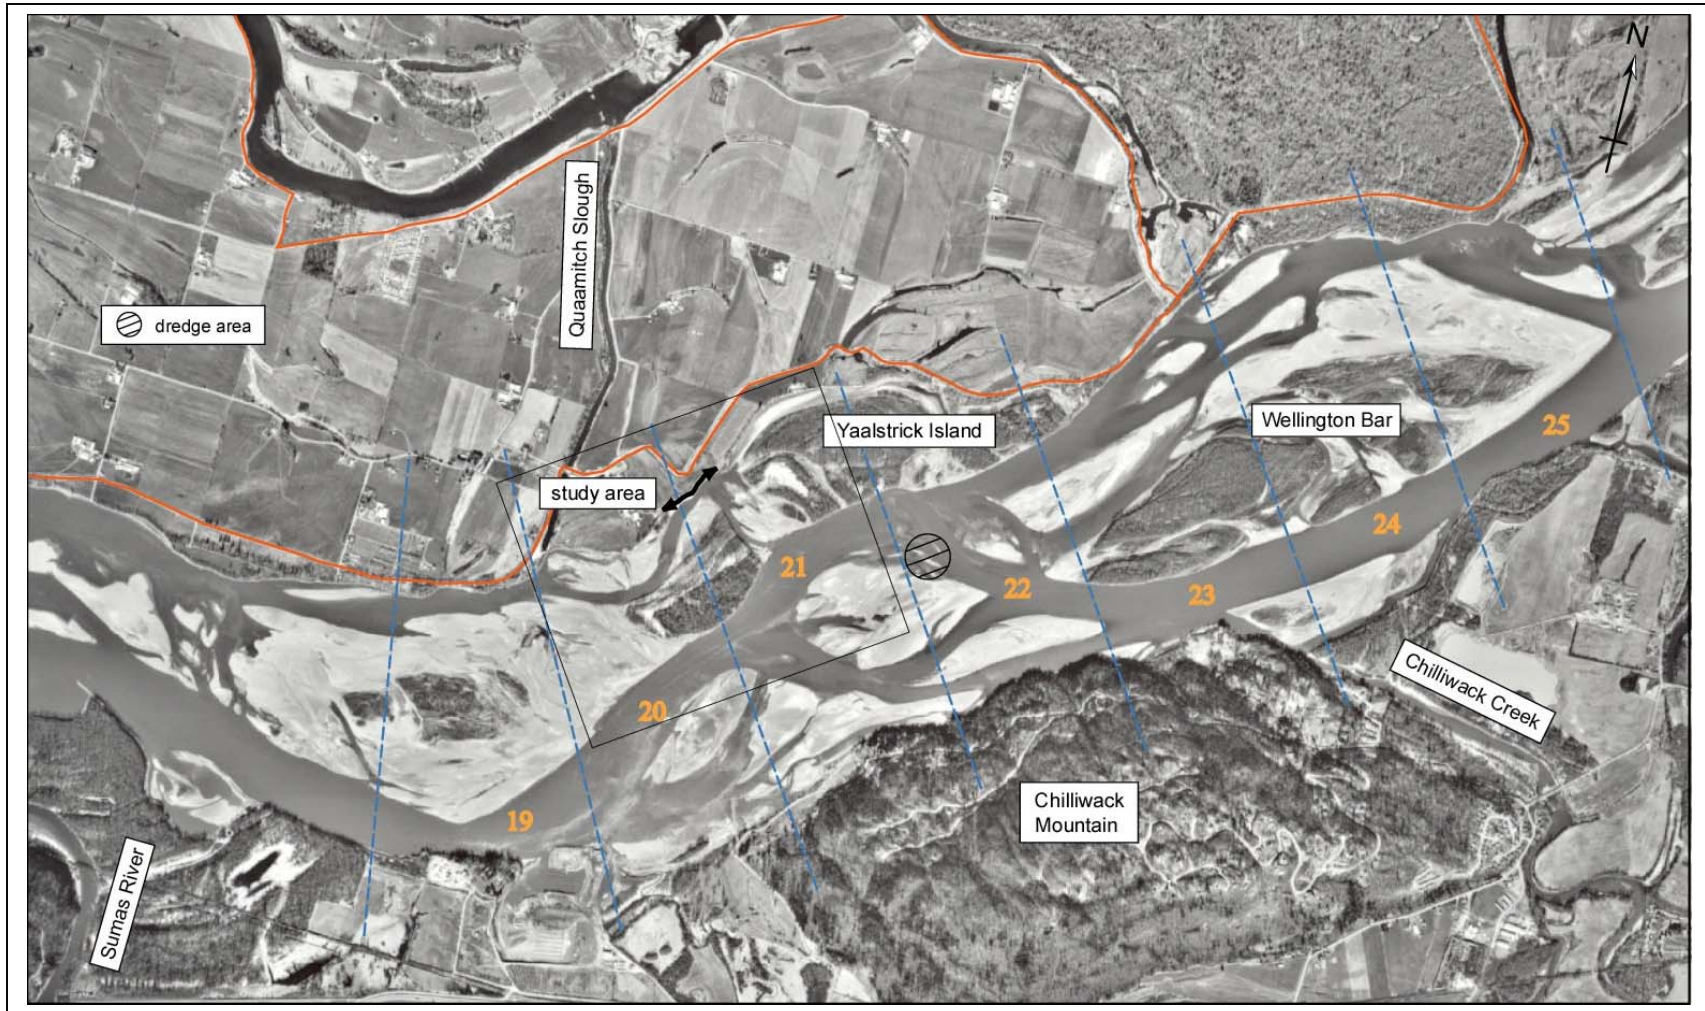
**Figure 1. Quaamitch Slough and vicinity, March 20, 1999; Mission flow 699 m<sup>3</sup>/s. Source Resource Surveys and Mapping Branch, British Columbia Ministry of Environment, Lands and Parks. Scale is approximately 1:35,000. To facilitate comparisons, a similar scale is maintained for Figures 3 through 7. Numbered cells are sediment budget accounting units while the red lines represent dike locations. The outlined area is the extent of Figure 2.**

The new configuration of the river due to increased flows in the southern channel is most apparent on the low flow photography of 1999 (Figure 1). Here flow in the southern channel encounters Chilliwack Mountain and significant gravel deposits, forcing a majority of the flow toward Yaalstrick Island. This configuration has resulted in flows being directed between the two islands of the Yaalstrick complex, allowing increased flows into the side channel and bank erosion at the study site. Despite the low flow of the 1999 photography, it is apparent that the side channel at the study site is considerably larger than in previous years.

Because flow in the southern channel tends to impinge on Chilliwack Mountain at an angle, not all of the flow is forced directly west toward Yaalstrick Island. Some of the flow passes through parallel to the bedrock, cutting through gravel deposits off Chilliwack Mountain. This division of flow is aided by gravel deposits at the Chilliwack Creek confluence, which force the flow offshore and allow more of it to run past the mountain (Figure 1).

Channel alignment around Wellington Bar is presently exercising control on the pattern of flow in the vicinity of the study site. As noted, more of the flow is presently entering the southern channel (left bank) where it flows in a southwesterly direction toward Chilliwack Mountain. When the river reaches the hard, high ground of the mountain and its associated gravel deposits, a majority of the flow is forced to the west directly toward Yaalstrick Island. This has resulted in increased flows into the side channel behind Yaalstrick Island and subsequent erosion at the study site, which lies opposite a major flood entrance to the side channel (Figure 1).

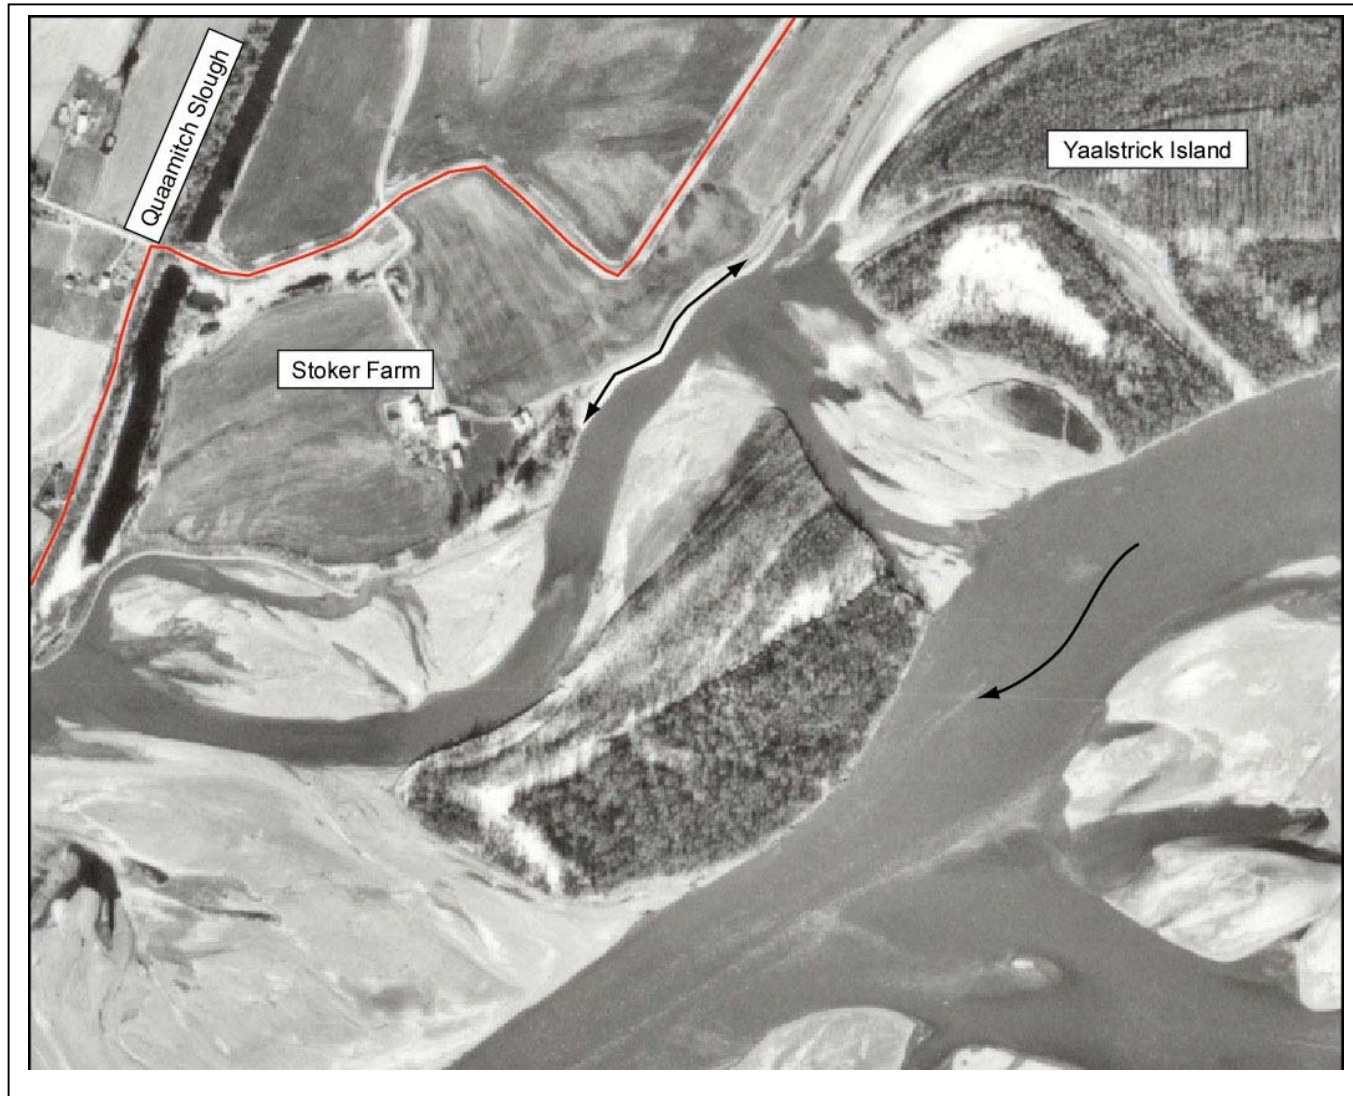
Figure 2 is a close-up view of the study site, showing the present extent of bank protection and the dyke, which is situated within 90 m of the active channel. Dykes surrounding Nicomen Island protect agricultural land and are of a lower standard than a majority of dykes in the area. Contemporary management objectives for the river are focused on the need to prevent flooding outside the channel zone of the river, and to discourage erosion beyond the active channel zone. Continued erosion at this site is in conflict with these objectives. There is also the potential for loss of property, with Stoker Farm situated immediately downstream of the site (Figure 2).

**Figure 2. Detailed view of study site, March 20, 1999. The black line shows the limit of bank protection constructed in 1996 and 1999. Bank erosion is now occurring downstream of the armouring. Scale is approximately 1:10,000.**

- 2. If the main channel were to maintain its present configuration, an alternative solution may be to build a rock spur off the downstream end of the riprap at the study site. This would guide the flow away from the unprotected banks. A rock spur would not have to be constructed to withstand excessive flows, since the side channel abstracts a relatively minor portion of the total flow.*

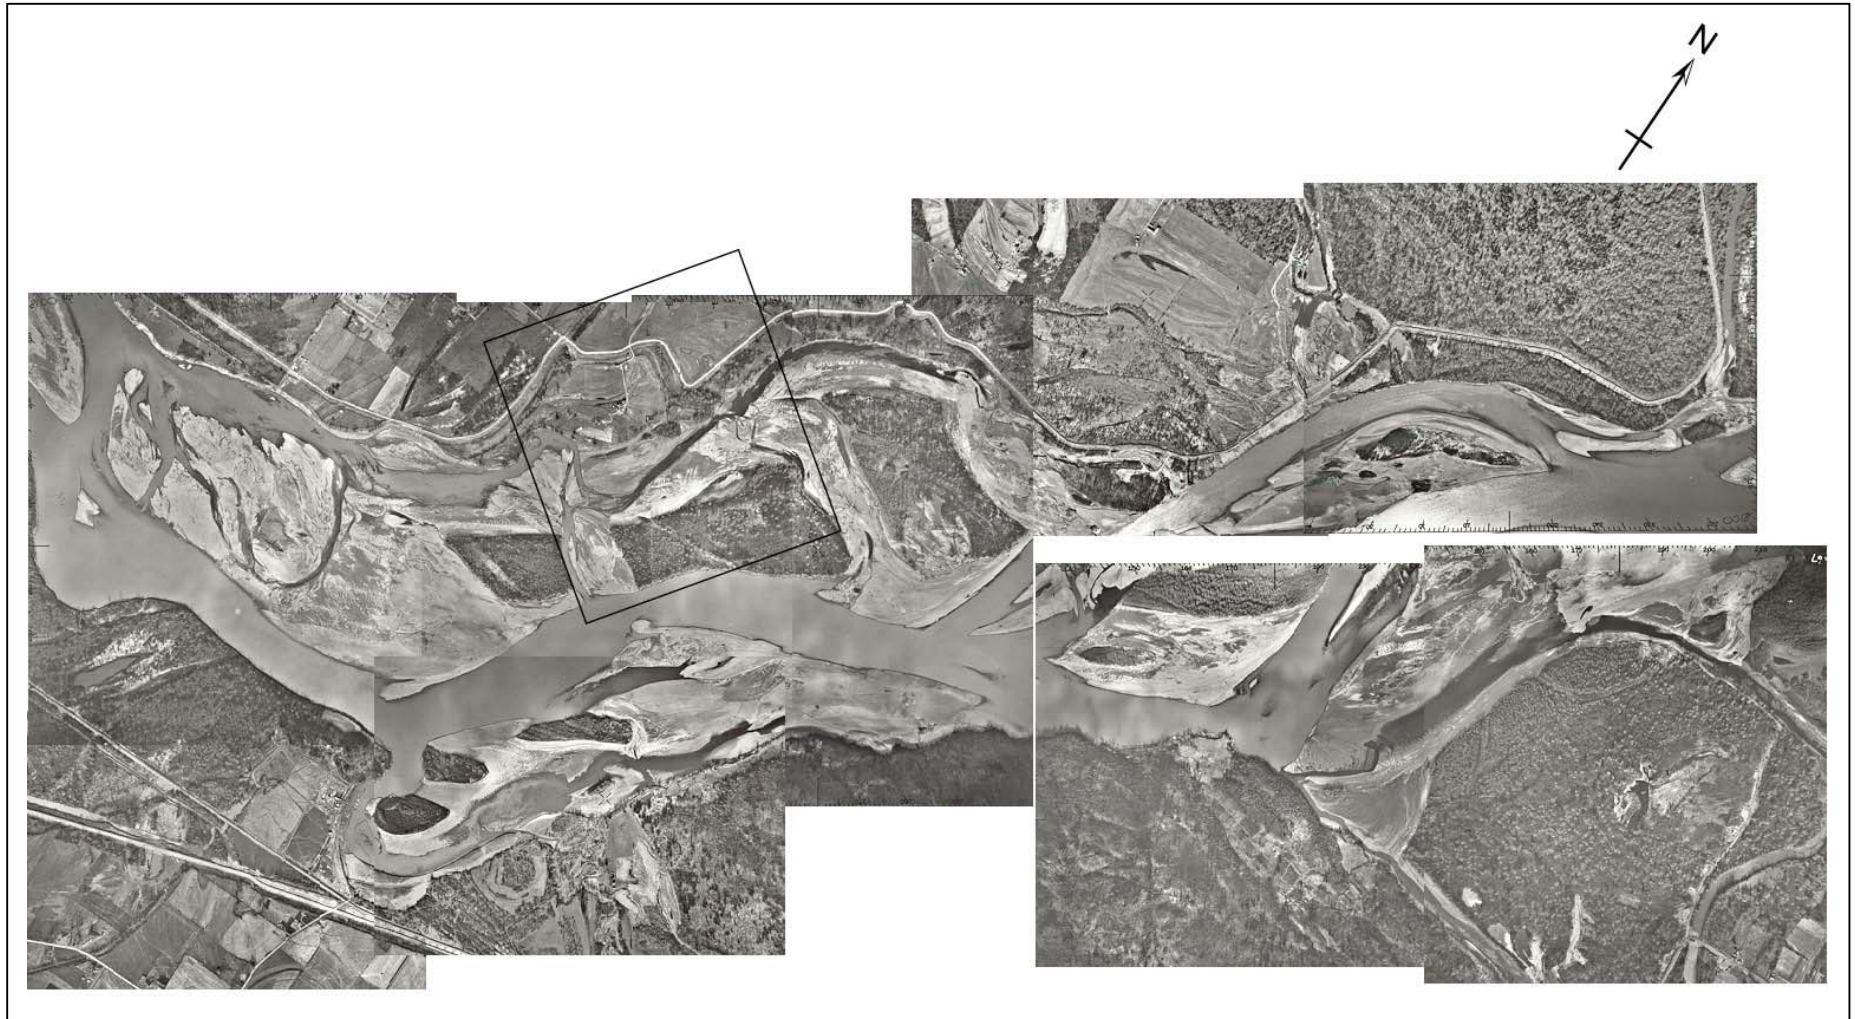
A comparison of the reach in 1949 and 1999 illustrates the relative continuity of deposits (Figures 1 and 3). The low flow of the 1949 photography reveals Wellington Bar, Yaalstrick Island and significant gravel bars on the flanks of Chilliwack Mountain and downstream of Yaalstrick – major channel elements that persist in 1999. Major differences between these dates are that a major channel divided Wellington Bar in 1949 and Yaalstrick Island was significantly larger (Figure 3). In addition, in 1999 a major channel sweeps along the western end of Wellington Bar to attack the bank of Yaalstrick Island (near the study site), and a flood channel carries the current past the island to impinge on the study site.

**Figure 3 Quaamitch Slough and vicinity, March 23, 1949; Hope flow 733 m<sup>3</sup>/s. Source Resource Surveys and Mapping Branch, British Columbia Ministry of Environment, Lands and Parks. The outlined area is the approximate extent of Figure 2.**

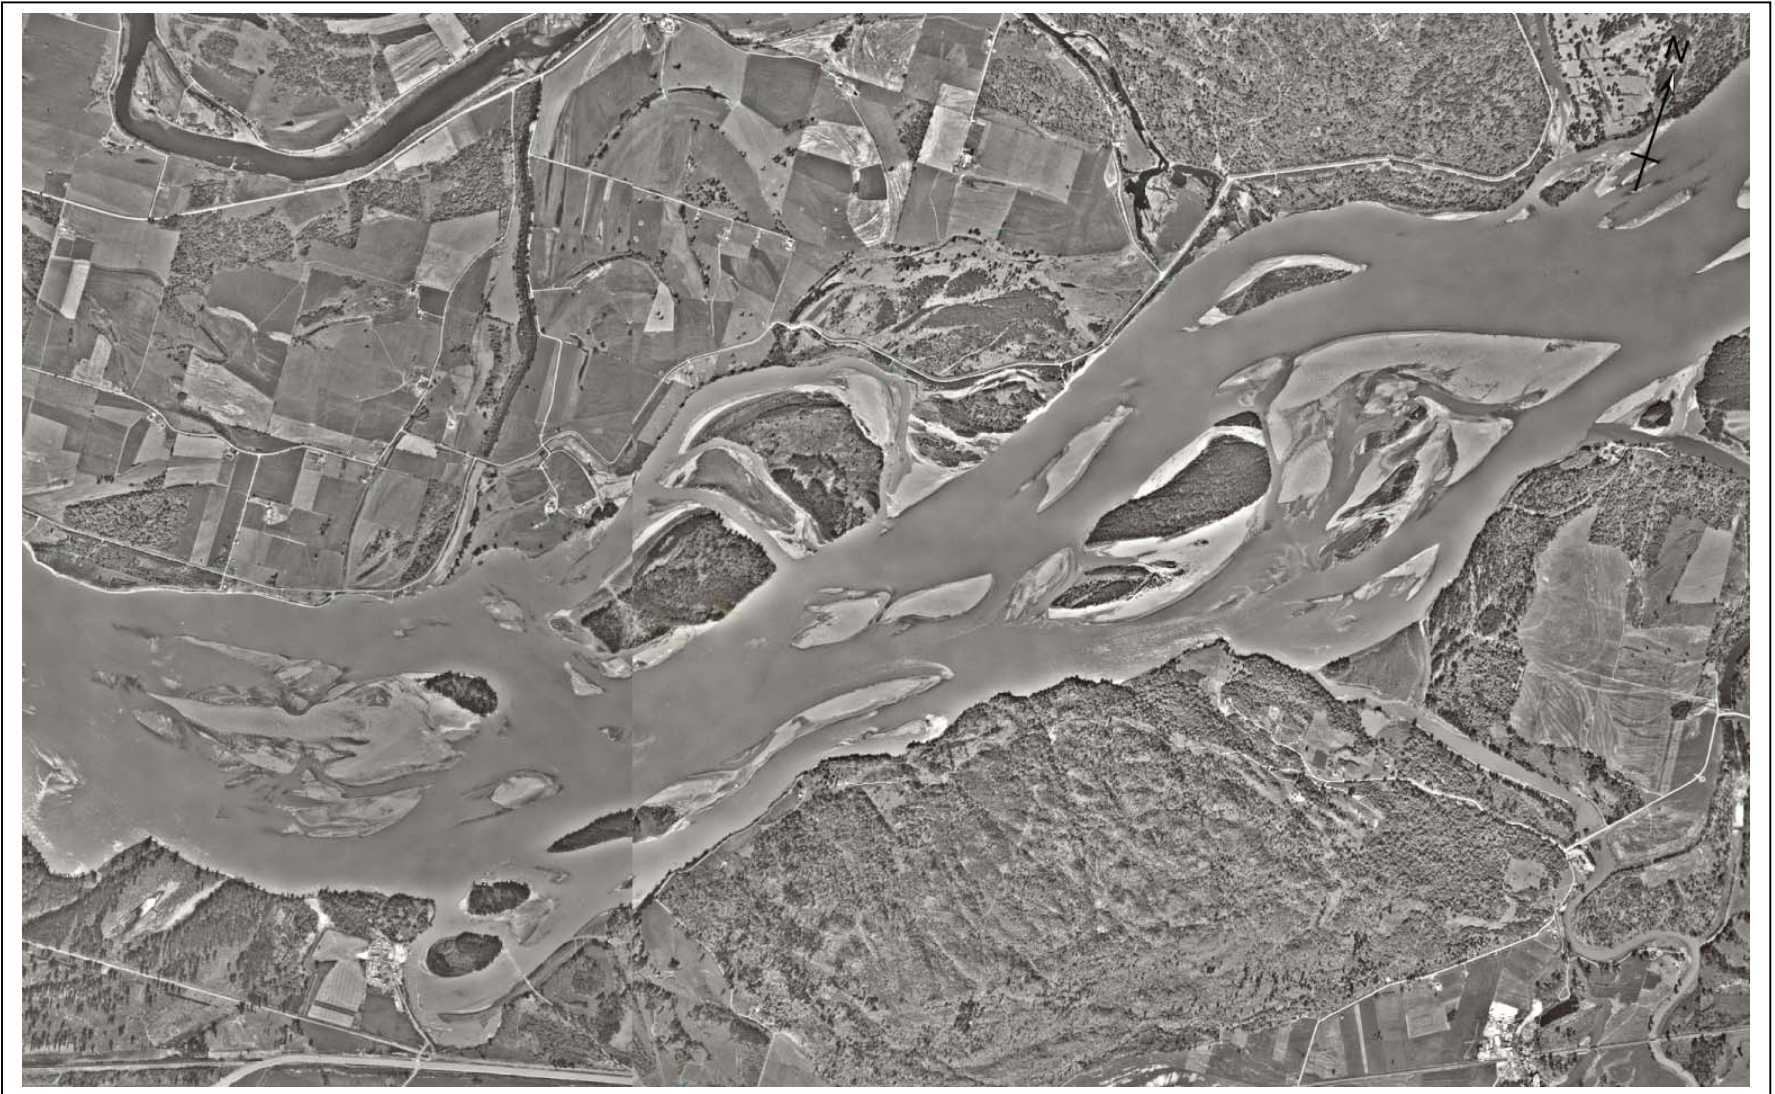
**Figure 4 Quaamitch Slough and vicinity, May 7, 1962; Hope flow 2,940 m<sup>3</sup>/s. Source Resource Surveys and Mapping Branch, British Columbia Ministry of Environment, Lands and Parks.**

The higher stage of the 1962 photography gives the appearance that the side channel behind Yaalstrick Island had abstracted increased flow between 1949 and 1962, but flow stage in the successive airphotos makes strict comparison difficult. A better comparison is with the 1971 photography, which was taken at a flow similar to that of 1949 (Figure 5). In both years the side channel appears as a narrow wetted channel, indicating a relatively shallow depth. A gravel bar was located immediately downstream of the study site in the 1949 photography. By 1971 the northern portion of the downstream island had grown toward the right bank, forcing the thalweg of the side channel against the bank downstream of the study site. However, no bank erosion occurred as a result of this minor channel adjustment.

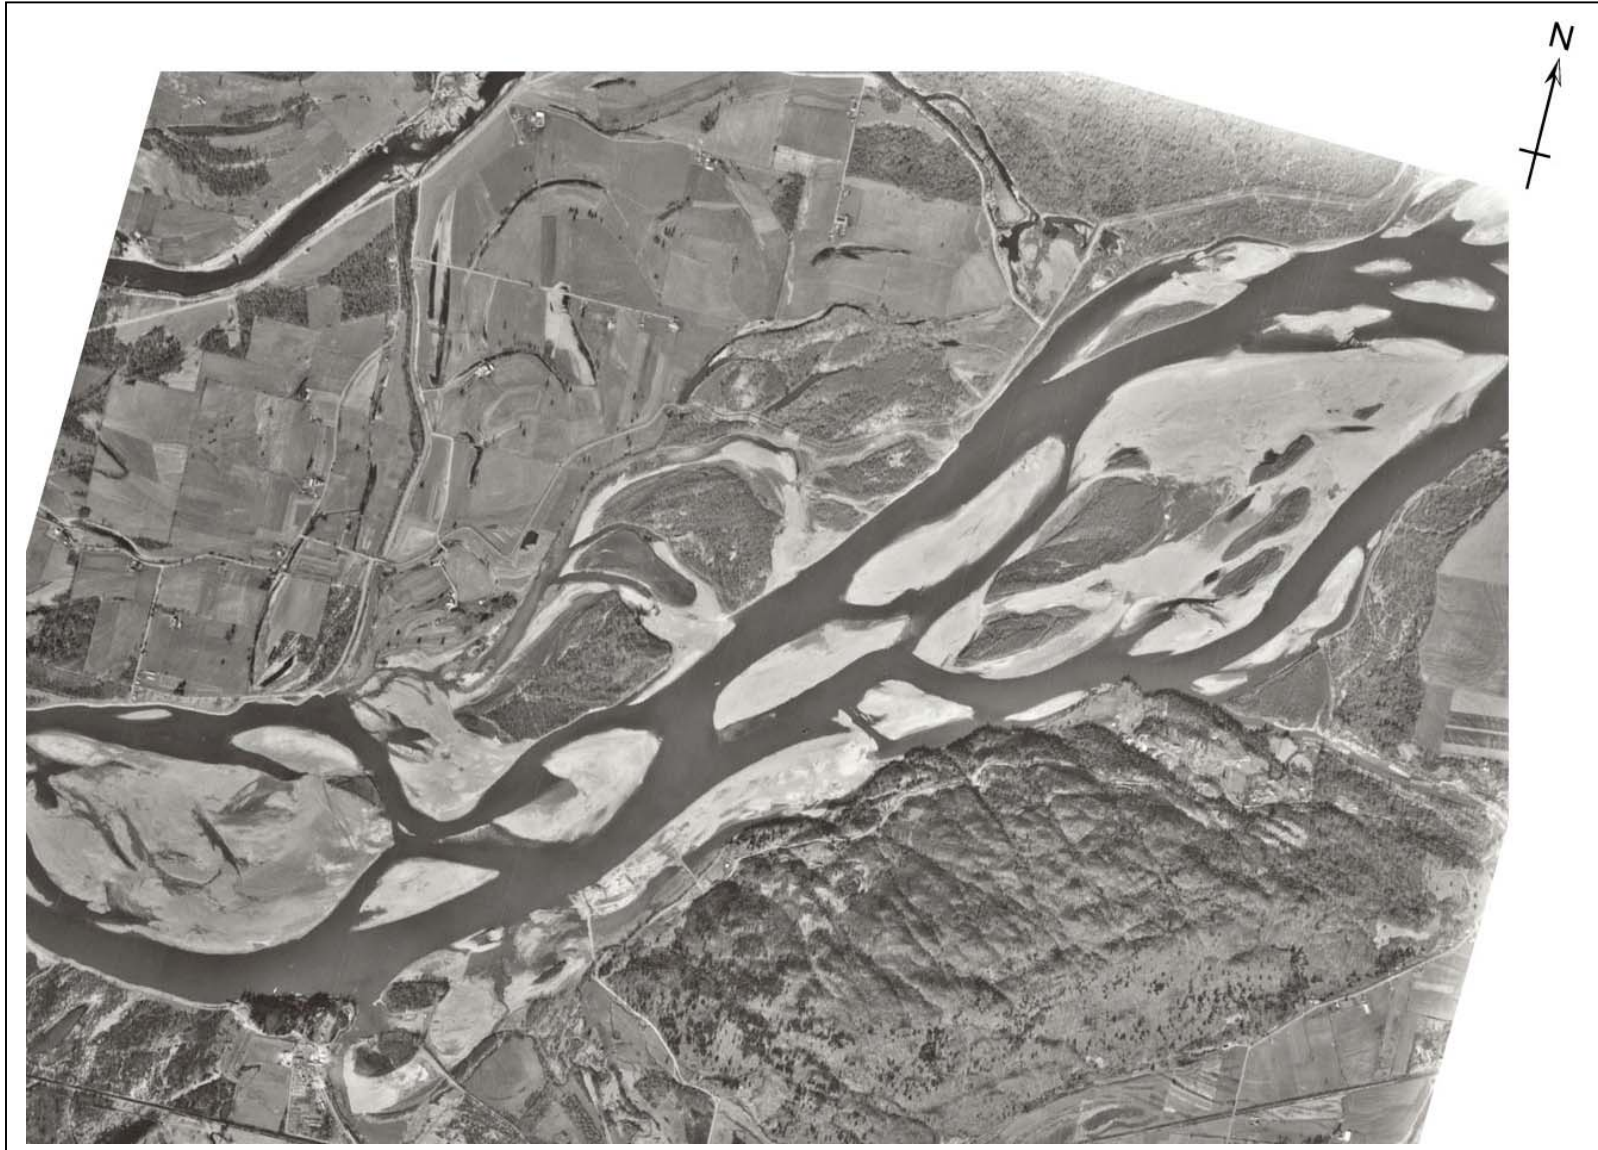
Of particular note on the 1971 photography is the development of several gravel bars in the northern channel (right bank) at the upstream end of Wellington Bar (Figure 5). Deposition continued in this area between 1971 and 1979, forcing more of the flow into the southern channel (Figure 6). Flow in the southern channel proceeded in a southwesterly direction until it encountered the hard, high ground of Chilliwack Mountain. In 1971, this southern flow was directed away from Yaalstrick Island by a gravel bar at the downstream end of Wellington Bar. However, by 1979 this bar had been eroded by increased flows and a majority of flow was directed toward the west, directly against Yaalstrick Island (Figure 6). This configuration resulted in direct erosion of Yaalstrick Island between 1983 and 1999 (Figure 8c). No significant changes appear to have occurred between 1979 and 1991, although the high stage of the 1991 photography makes comparison difficult (Figure 7)

**Figure 5 Quaamitch Slough and vicinity, March 19, 1971; Hope flow 799 m<sup>3</sup>/s. Source Resource Surveys and Mapping Branch, British Columbia Ministry of Environment, Lands and Parks.**

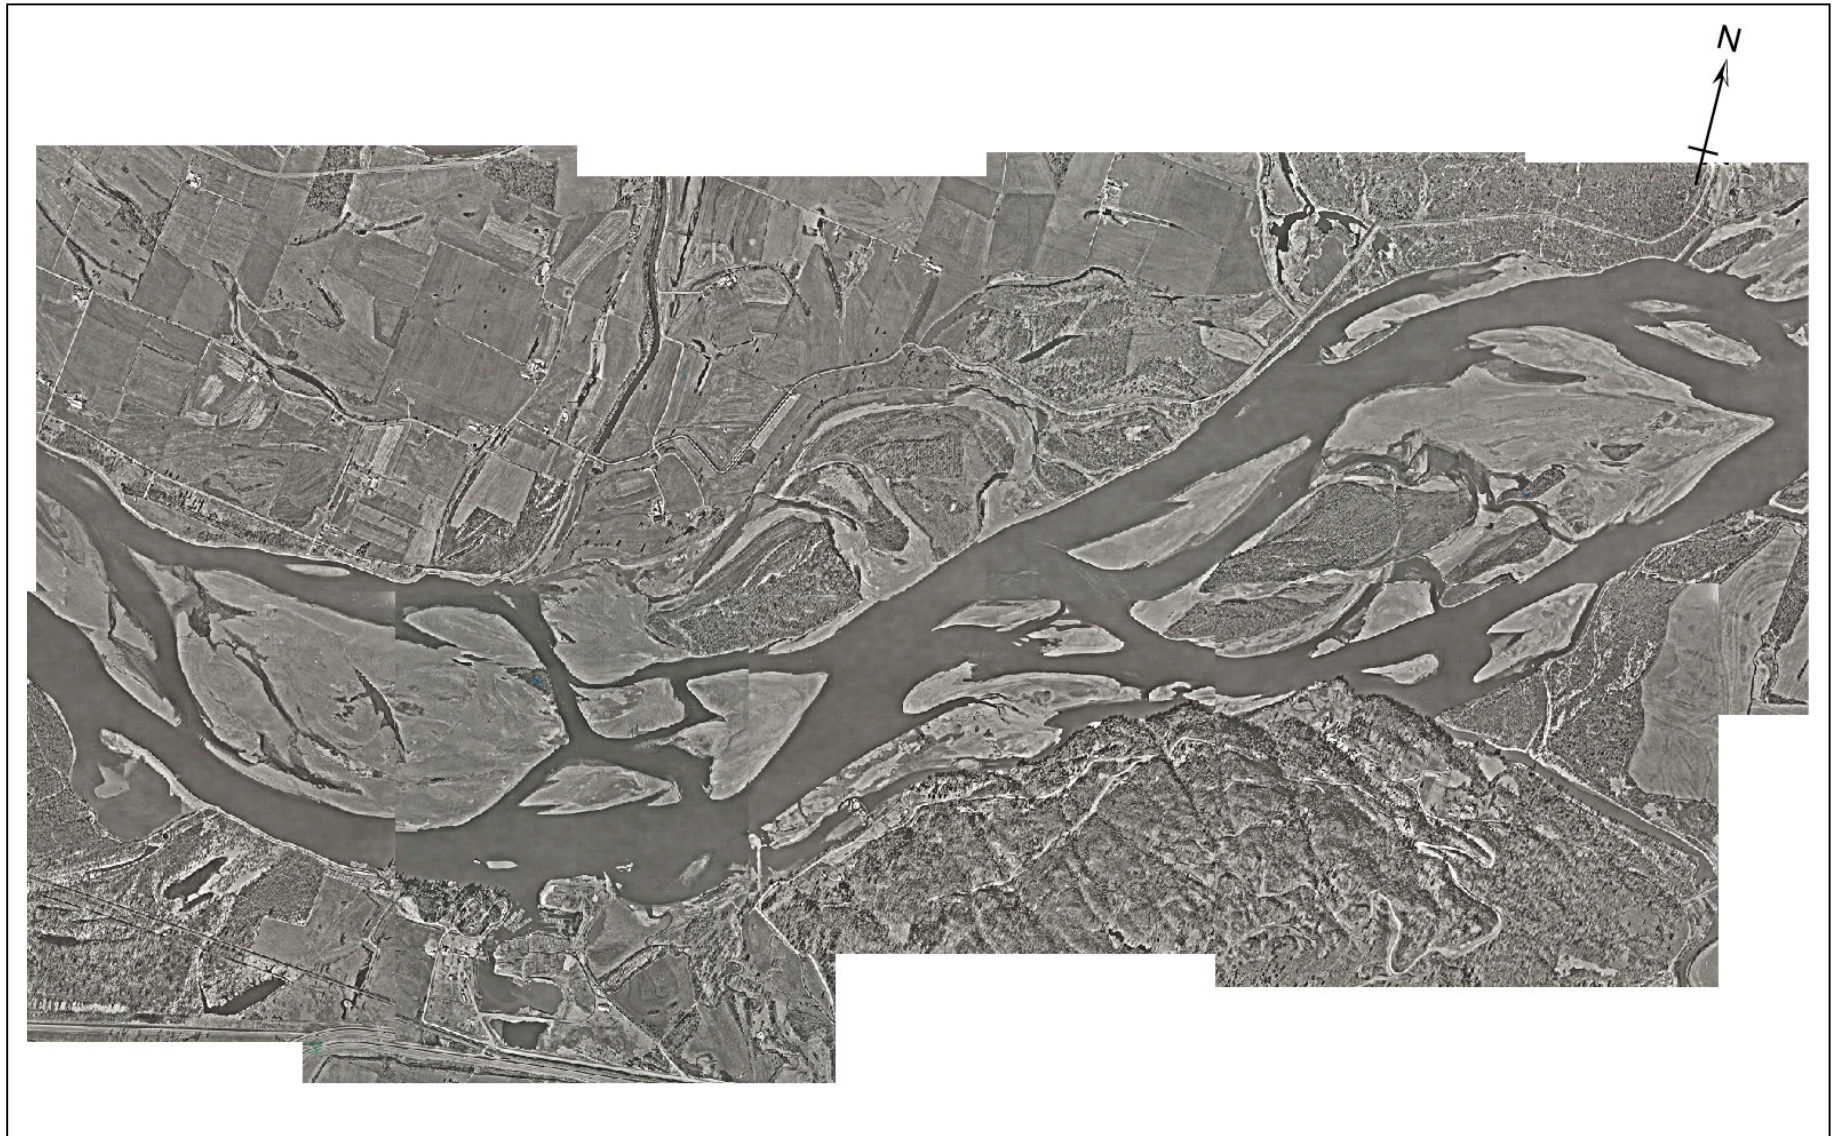
**Figure 6 Quaamitch Slough and vicinity, March 22, 1979; Hope flow 1,010 m<sup>3</sup>/s. Source Resource Surveys and Mapping Branch, British Columbia Ministry of Environment, Lands and Parks.**

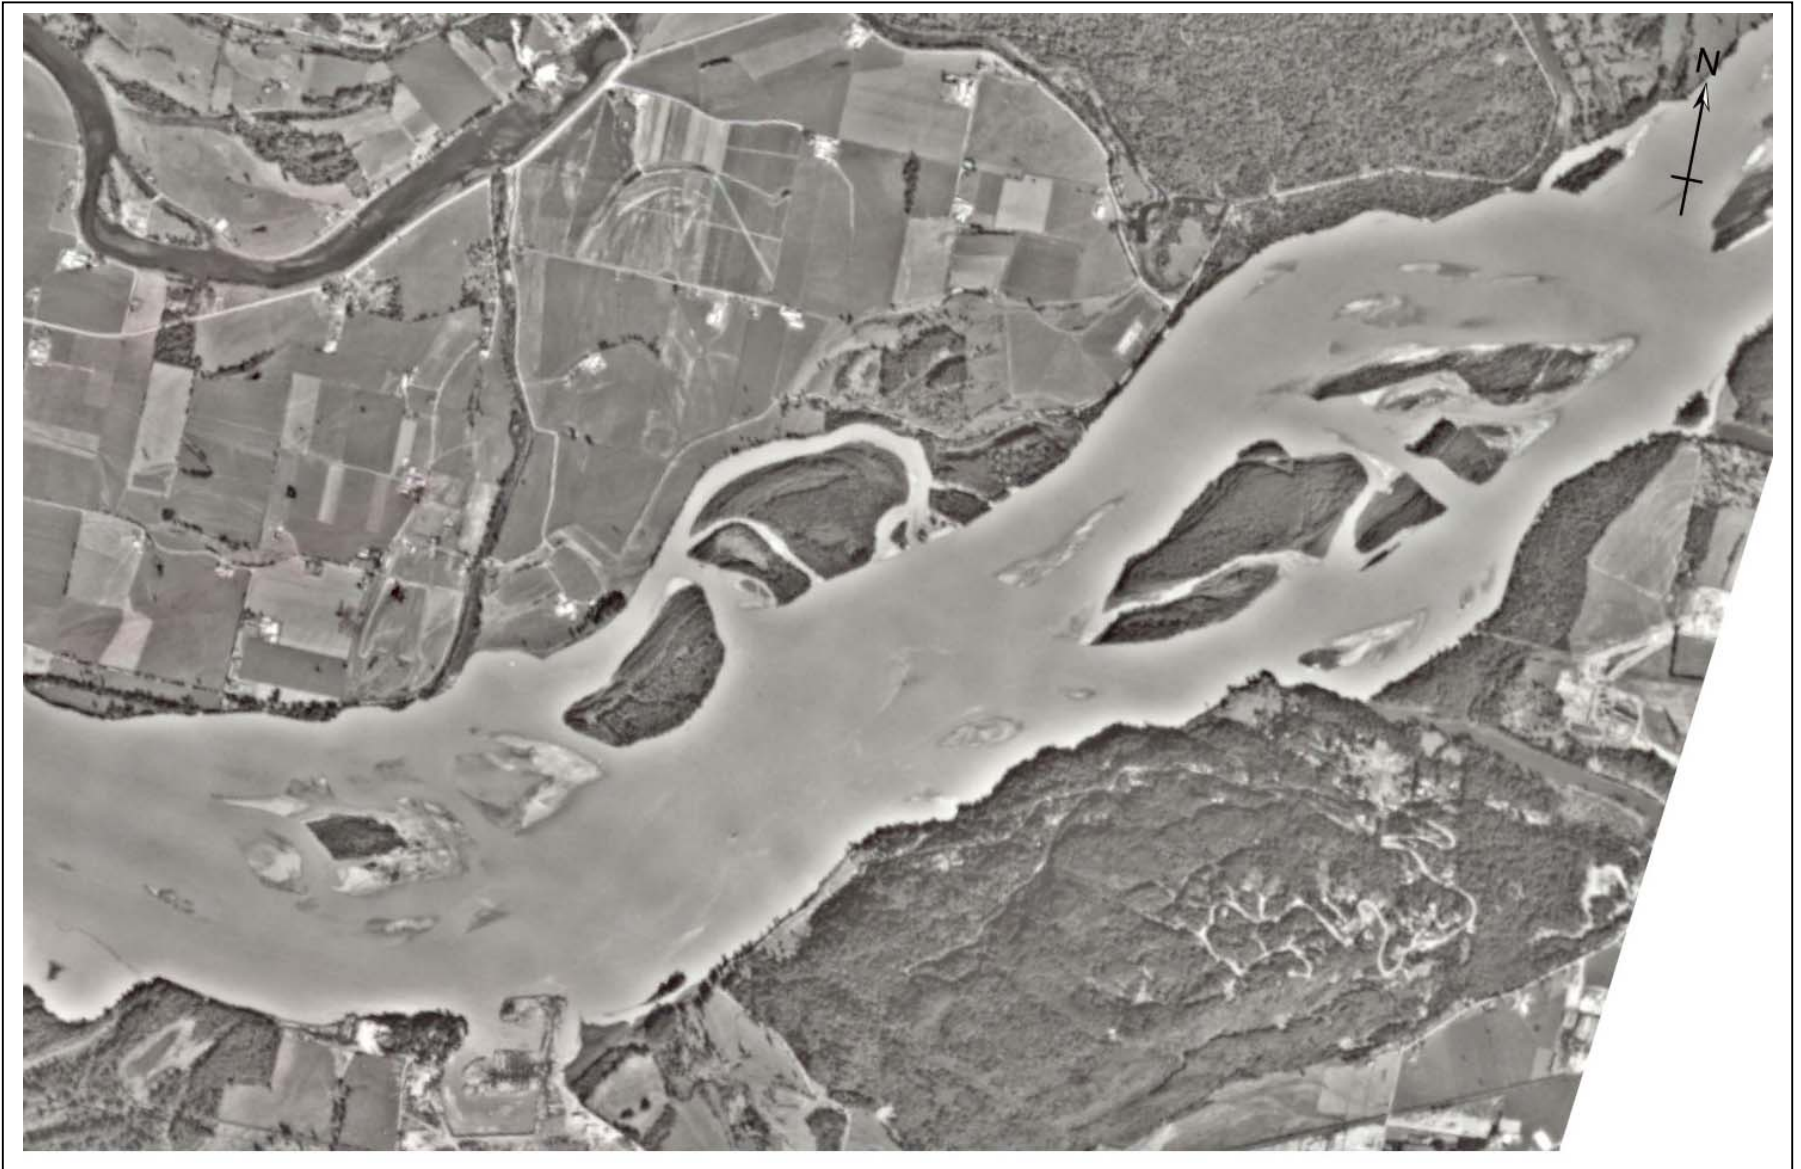
**Figure 7 Quaamitch Slough and vicinity, September 5, 1991; Hope flow 4,410 m<sup>3</sup>/s. Source Resource Surveys and Mapping Branch, British Columbia Ministry of Environment, Lands and Parks.**

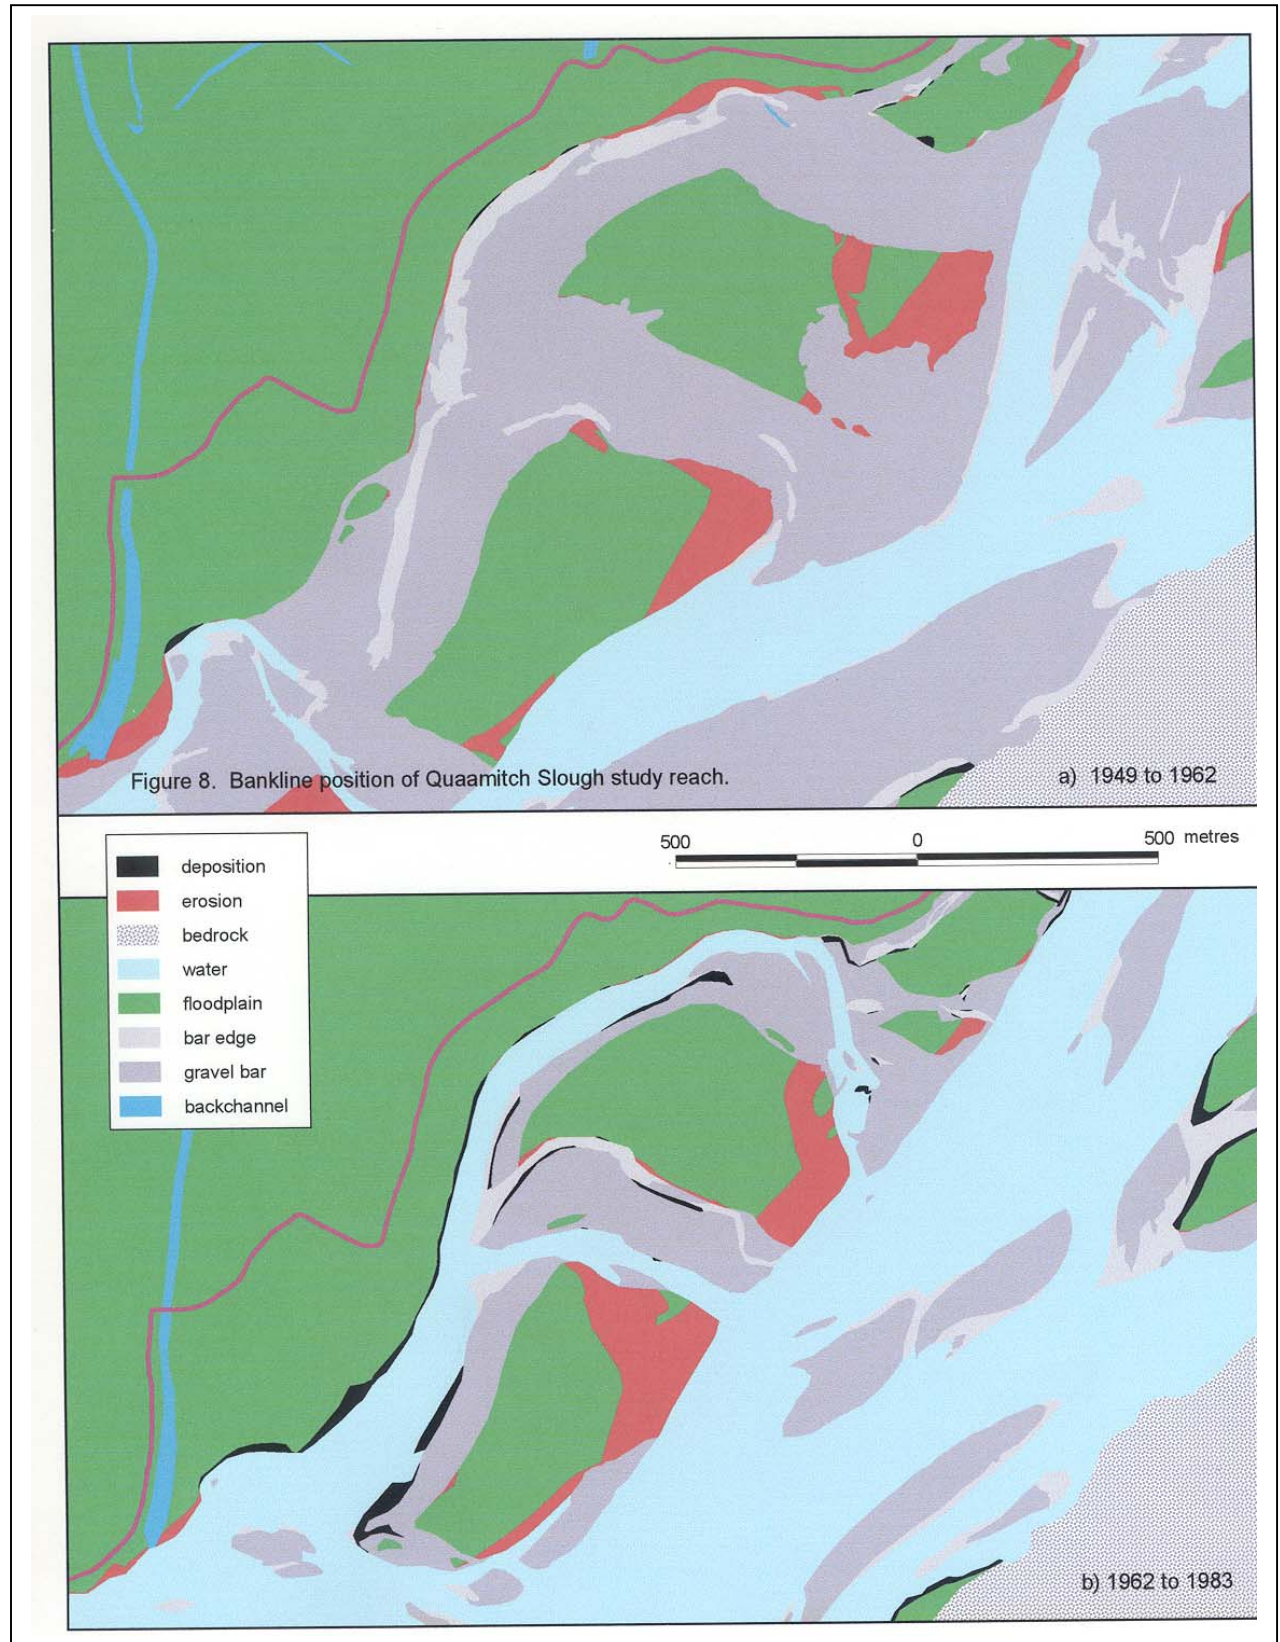
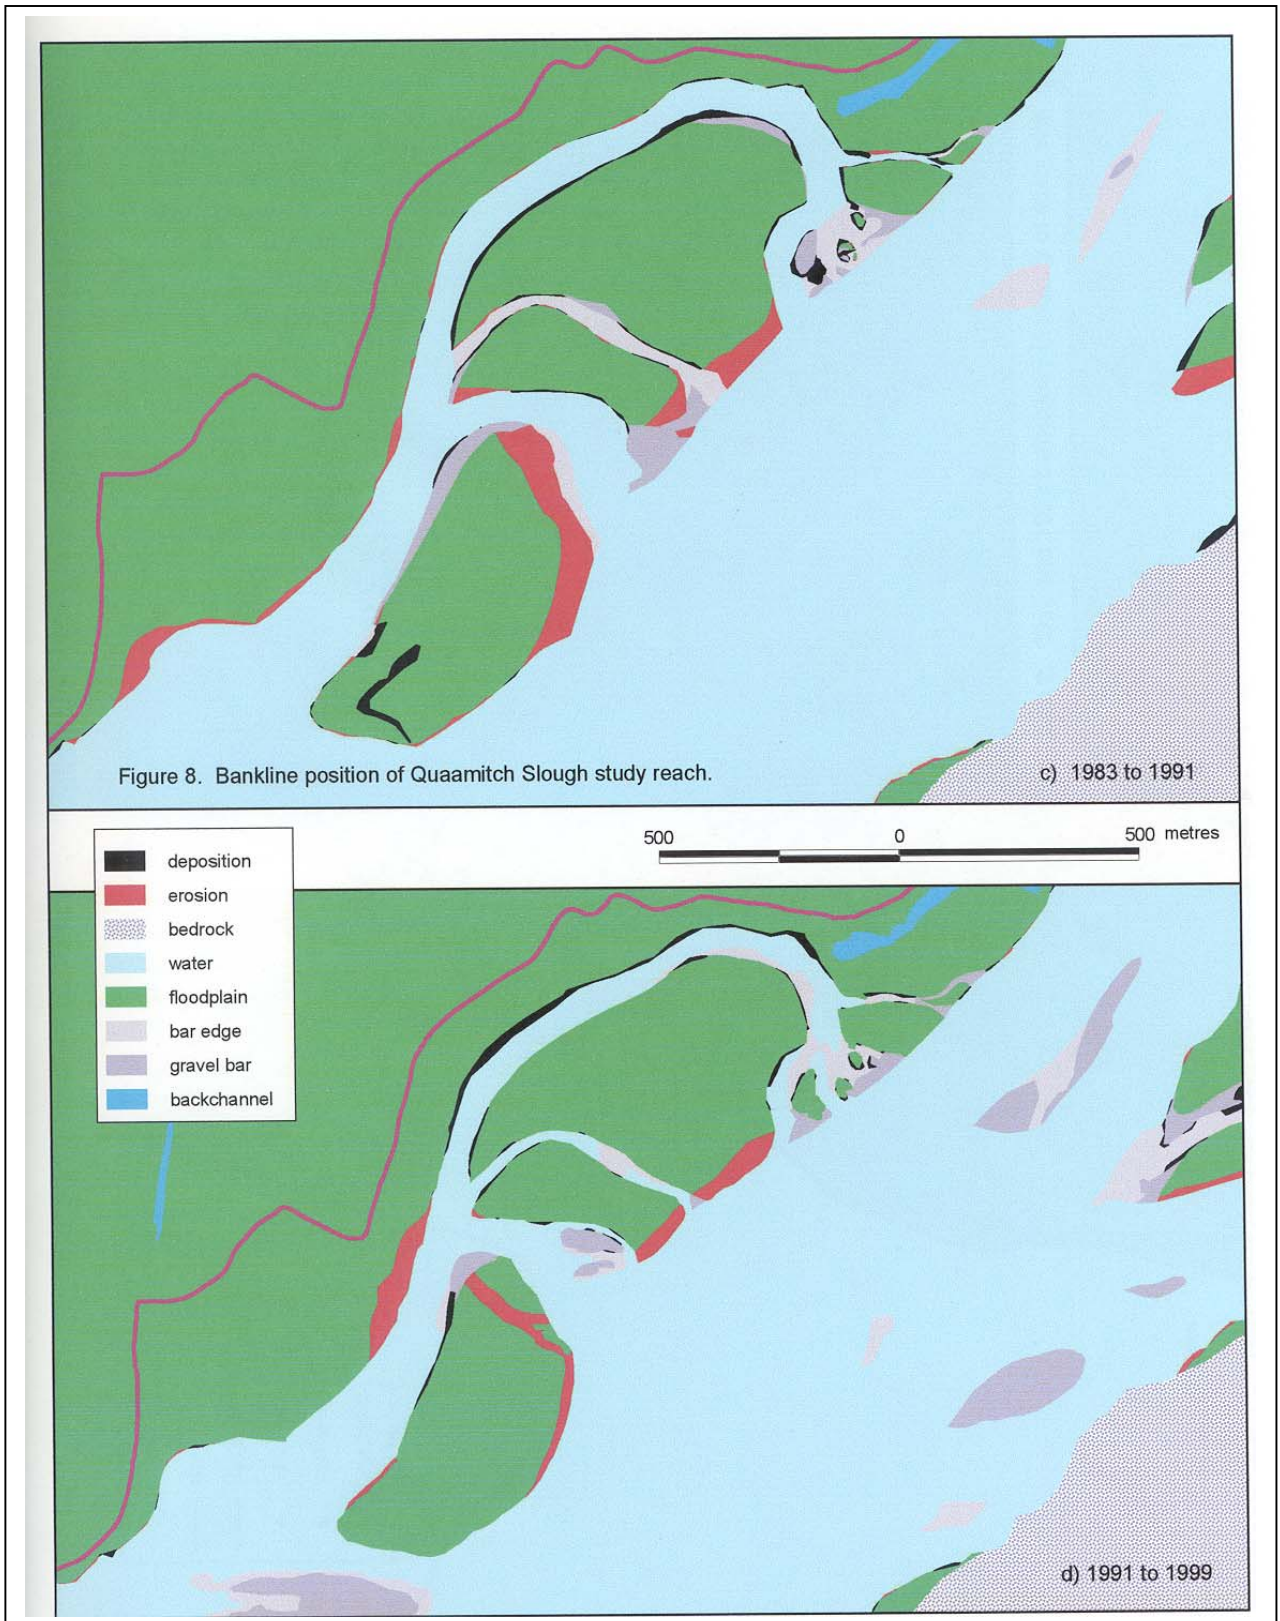
Figure 8 Bankline position of Quaamitch Slough study reach.

The changes described above can be assessed quantitatively by using historic maps of channel, bar, island and bankline positions. By digitizing airphotos for the gravel reach of Fraser River, channel maps for 1949, 1962, 1983, 1991 and 1999 have been created. Bankline positions from these years for the study site have been plotted on Figure 8a to 8d. Erosion of the study site and Yaalstrick Island between these dates is as follows:

The active erosion of Yaalstrick Island between 1949 and 1983 is a product of more flow being abstracted by the northern channel past Wellington Bar, thereby attacking the southern bank of the island complex. Erosion since 1983 is a result of more flow shifting into the southern channel and being directed against the island by Chilliwack Mountain and its associated gravel deposits. This latter channel configuration is also responsible for increased erosion at the study site, as more flow is being directed into the side channel. Between 1983 and 1991, most of the erosion in the side channel occurred at the downstream end of the island complex, but up to 25 m of lateral erosion did occur at the study site (Figure 8c). After 1991 bank erosion at the study site was more significant with up to 75 m of erosion.

It should be noted that the deposition and erosion areas shown on Figure 8 refer to island/floodplain creation and destruction. They do not refer to within channel changes, such as from gravel bar to channel or gravel bar to island. Such changes have no reference on these maps since each year represents a different flow level (for example, 1991 was a year of high flow and hence there is little gravel bar area showing in comparison with other years).
