Matsqui Bend Erosion

prepared for
Ministry of Environment, Lands and Parks
10334 152A Street
Surrey, British Columbia, V3R 7P8

by
Hamish Weatherly, Michael Church, and Darren Ham
Department of Geography
The University of British Columbia
Vancouver, British Columbia, V6T 1Z2

October 18, 1999

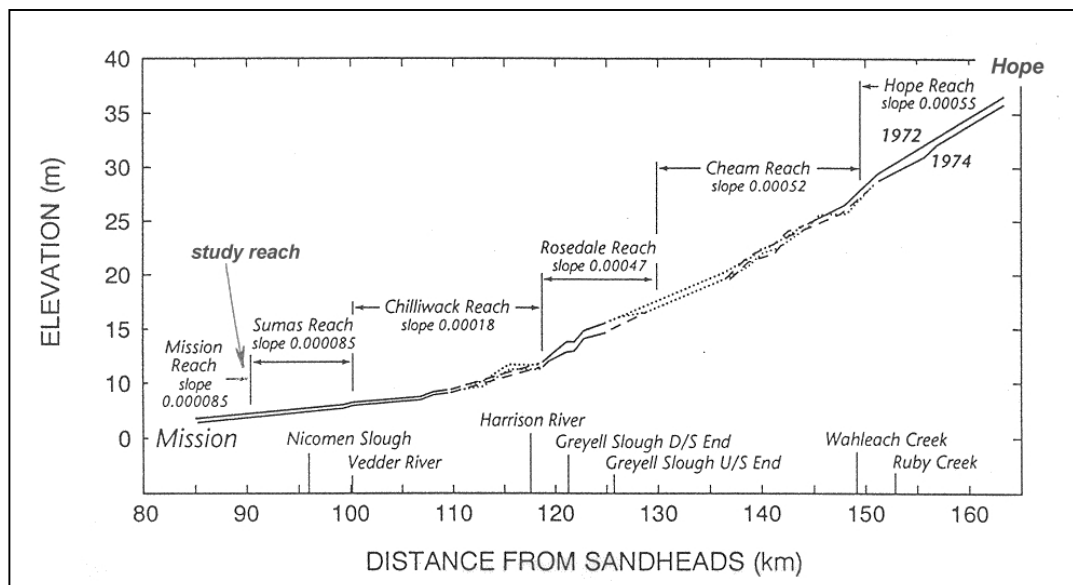
Figure 2 Long profile of lower Fraser River between Hope and Mission, where the gradient declines most rapidly. Sumas Mountain, upstream from Mission, represents the limit of tidal influence on the river.

Between the downstream end of Fraser Canyon and Sumas Mountain, Fraser River flows on a gravel bed consisting of sediments transported and deposited by the river. Such deposits build up where the gradient of a river declines so that the flow is no longer sufficiently powerful to move the entire sediment load further downstream. Fraser River encounters a rapidly declining gradient after it leaves the Canyon and approaches the sea in the Lower Mainland (Figure 2).

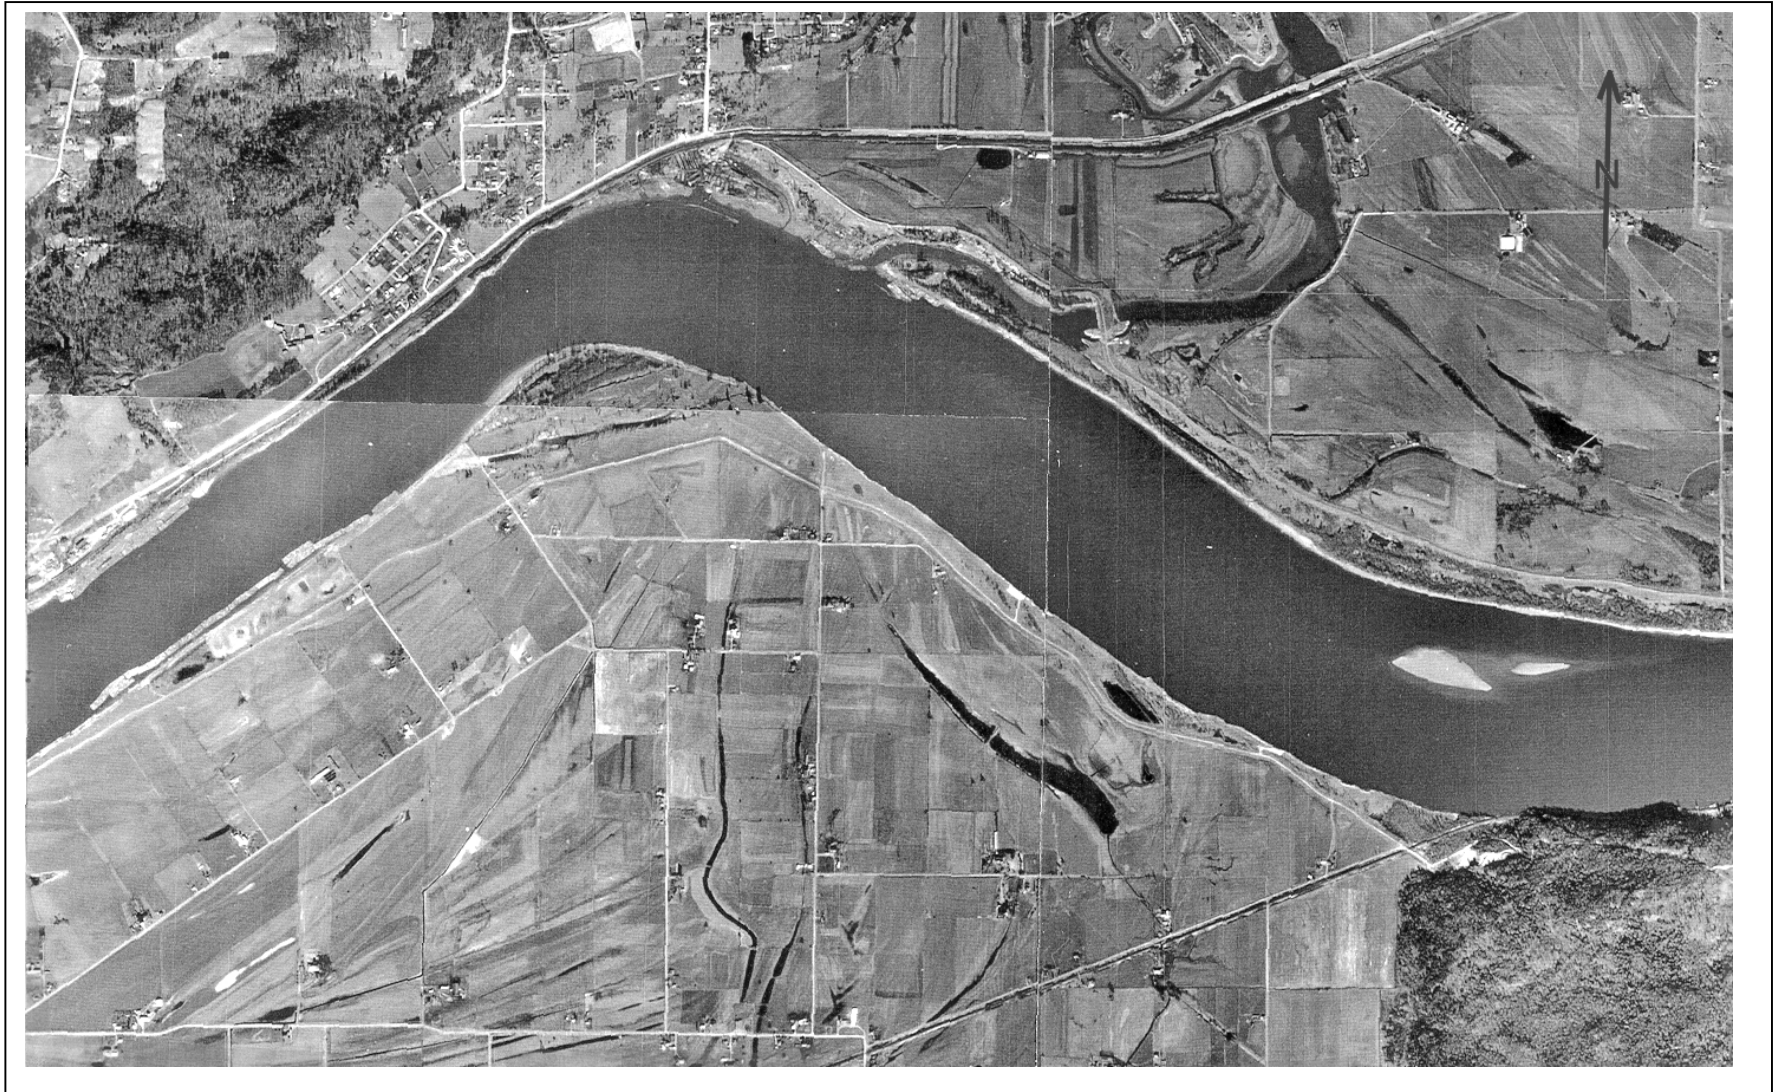
Figure 3 Air photo mosaic of the study reach, March 19, 1971; Hope flow 799 m³/s. Airphotos BC5046-75, 77, 127, 129; source Resource Surveys and Mapping Branch, British Columbia Ministry of Environment, Lands and Parks.

However, the erosion in 1997 is an indication that the channel morphology of this reach is not fixed. A review of the historic airphotos reinforces this point. Air photography of March 20th, 1999 reveals that a major lateral bar, herein referred to as Matsqui Bar, has developed on the right-hand side of the river upstream of the Hatzic Slough log sort and booming ground and downstream of the gravel bar at km 92 (Figure 1). The effect of this deposition is to divert flows toward the left bank of the river. The erosion points of 1997 are in line with the diverted flow. This bar is also visible during low flow in both 1991 and 1979, but not on March 19th, 1971 when flows were extremely low ($799 \text{ m}^3/\text{s}$) (Figure 3). It appears then that Matsqui Bar has developed within the past thirty years.

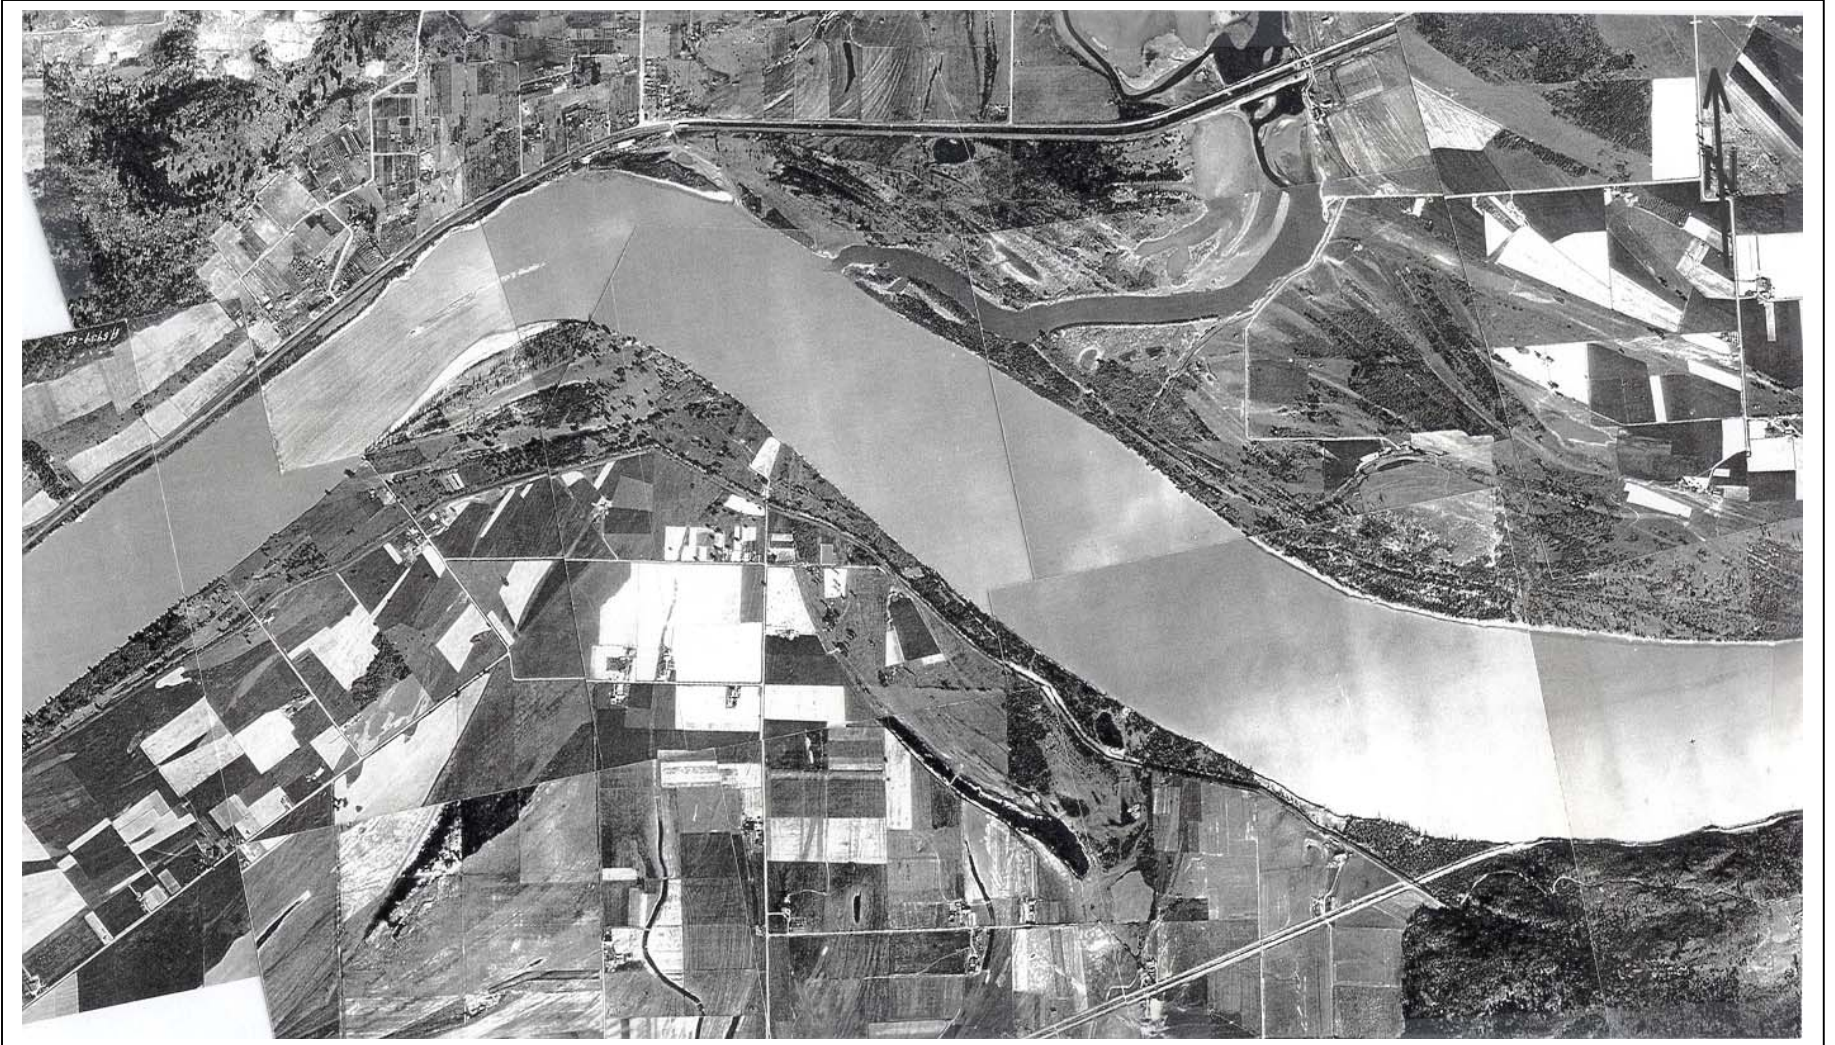
Figure 4 Air photo mosaic of the study reach, April 7, 1938; Hope flow $750 \text{ m}^3/\text{s}$. Airphotos BC5046-75, 77, 127, 129; source National Air Photo Library, Canada Department of Natural Resources.

Air photography from 1938 (Figure 4) indicates that the channel alignment has remained relatively unchanged, for the most part, over the past sixty years. However, it is apparent that some bank erosion occurred on the inside of the bend between 1938 and 1971. That photo also reveals no evidence of the gravel bar at km 92, which has been present since at least the 1960's.

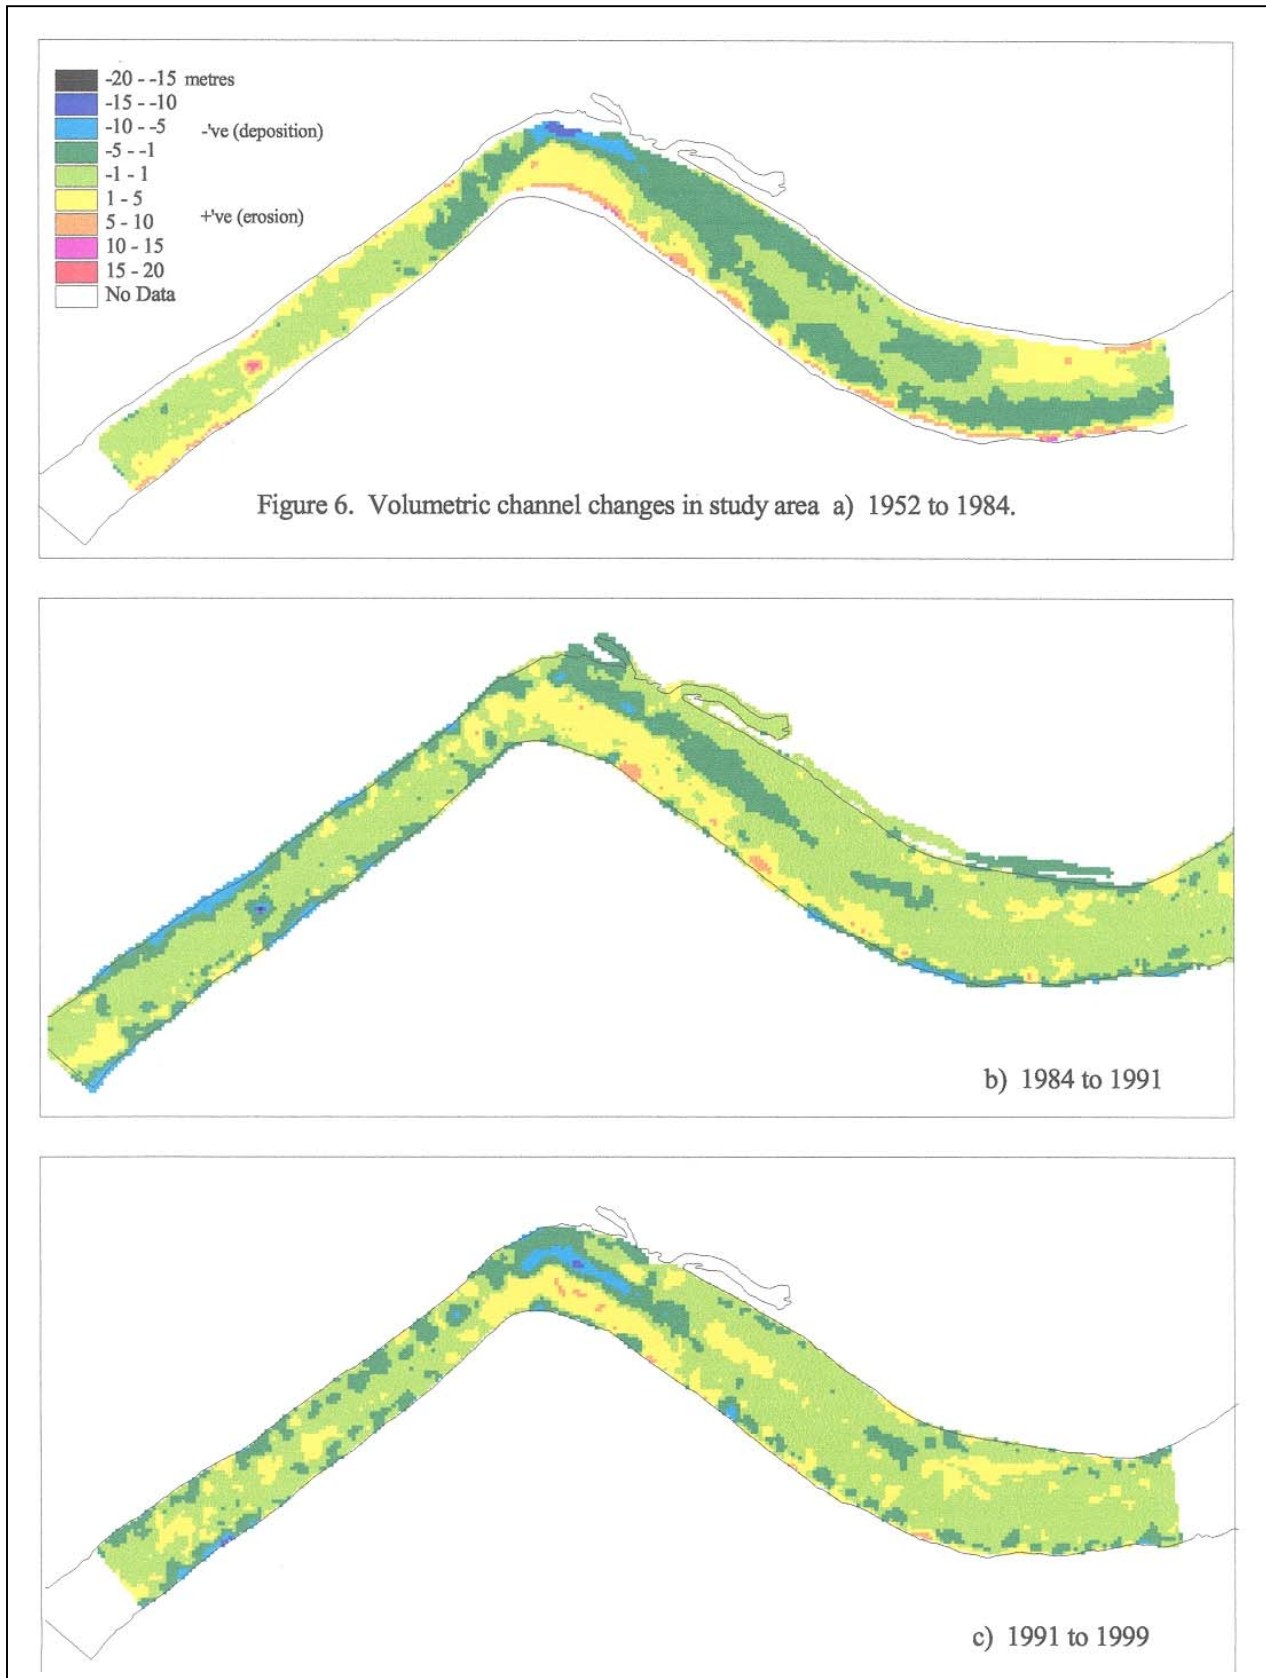
² Channel changes between survey dates are represented as changes in bed elevation in Figure 6. Darker coloured areas represent deposition (in metres) between survey dates while lighter colours represent erosion.

Figure 6 Volumetric channel changes in study reach: a) 1952 to 1984, b) 1984 to 1991, and c) 1991 to 1999.

A comparison of the channel bathymetry between 1952 and 1984 indicates that the net change in the reach is -100,000 m³ of sediment (the reach extends from the downstream end of Sumas Mountain to one kilometre upstream of the Mission Bridge, a distance of 6.7 km and a channel area of 4.4 km²). Consistent with the general depositional trend along the gravel-bed reach, however, this value is not indicative of localized erosional and depositional changes. The large bar accumulating upstream of the log sort clearly shows up as an area of deposition in Figure 6a². In response to this aggradation, there has been compensating erosion on the inside left bank as flows have been diverted away from the right-hand side. The most dramatic aggradation has occurred on the outside of the meander where there has been up to 16 m of deposition. Flows normally tend to be highest on the outside of meander bends and scour holes develop in response. In this case, the outside scour hole has been infilled with sediment as the channel and

scoured zone have shifted toward a straighter alignment. The same pattern of deposition and erosion is evident between 1984 and 1991, and 1991 to 1999 (Figure 6 b and c). As before, however, the net change is not large (Table 1). It should be noted that these figures represent bulk volumes, not mineral volume (i.e., porosity has not been accounted for).
