Mount Woodside Erosion
(Kent Site G-1)

prepared for
Ministry of Environment, Lands and Parks
10334 152A Street
Surrey, British Columbia, V3R 7P8

by
Hamish Weatherly and Micheal Church
Department of Geography
The University of British Columbia
Vancouver, British Columbia, V6T 1Z2

December 4, 2000

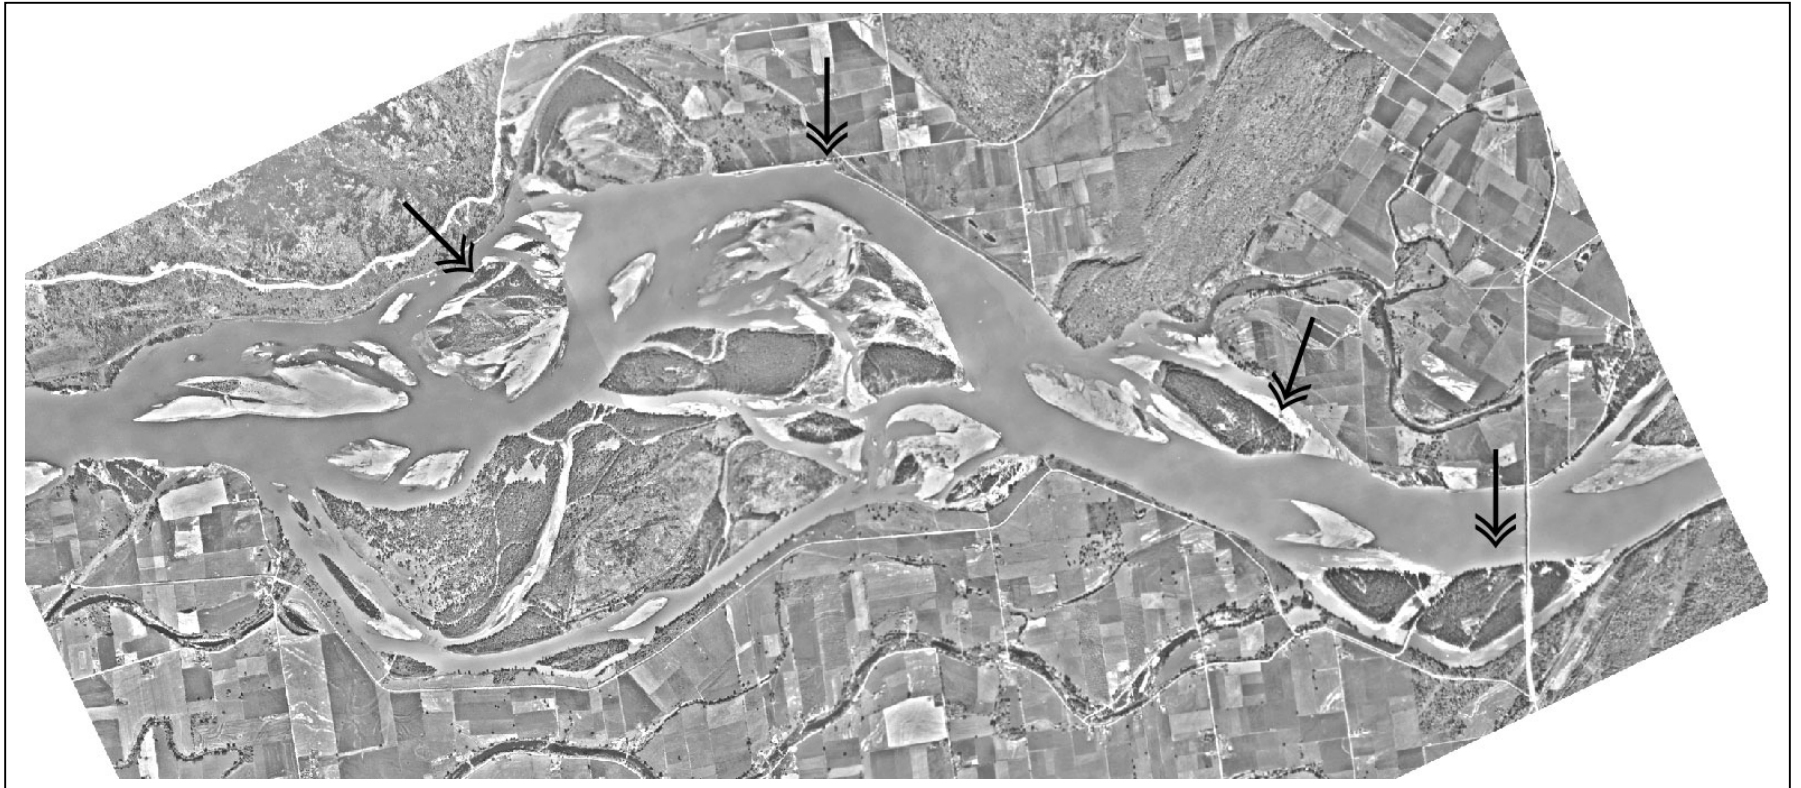
Figure 4 Island 32 and vicinity, May 7, 1962; Hope flow 2,940 m³/s. Source Resource Surveys and Mapping Branch, British Columbia Ministry of Environment, Lands and Parks. Arrows indicate sites of erosional attack.

During the 1950's erosion occurred in front of Ferry Island as the thalweg of the river moved toward the left bank at the Agassiz-Rosedale bridge site, and a crescentic bar appeared immediately downstream (off Island 32), probably the deposit of most of the material eroded upstream. This began to turn the river toward the long-established bar-island on the right bank immediately upstream of Hopyard Hill. The upstream end of this bar-island came under erosional attack, leading to the downstream growth of the bar off Hopyard Hill. Nearer the study site, erosion of the right bank continued between 1949 and 1962, as the point bar off Gill Island persistently grew outward and downstream (Figure 4). Eastern portions of the point bar had begun to vegetate as the main flow formed a tightening meander around the Gill Island complex. The apex of the meander also shifted slightly to the west and, as a result, the remaining small island off Site G-1 was eroded. It is not known whether the north bank was ripped by this time but the airphotos show that the apex of the meander bend is hard against a road and somewhat flattened, indicating a resistant bar.

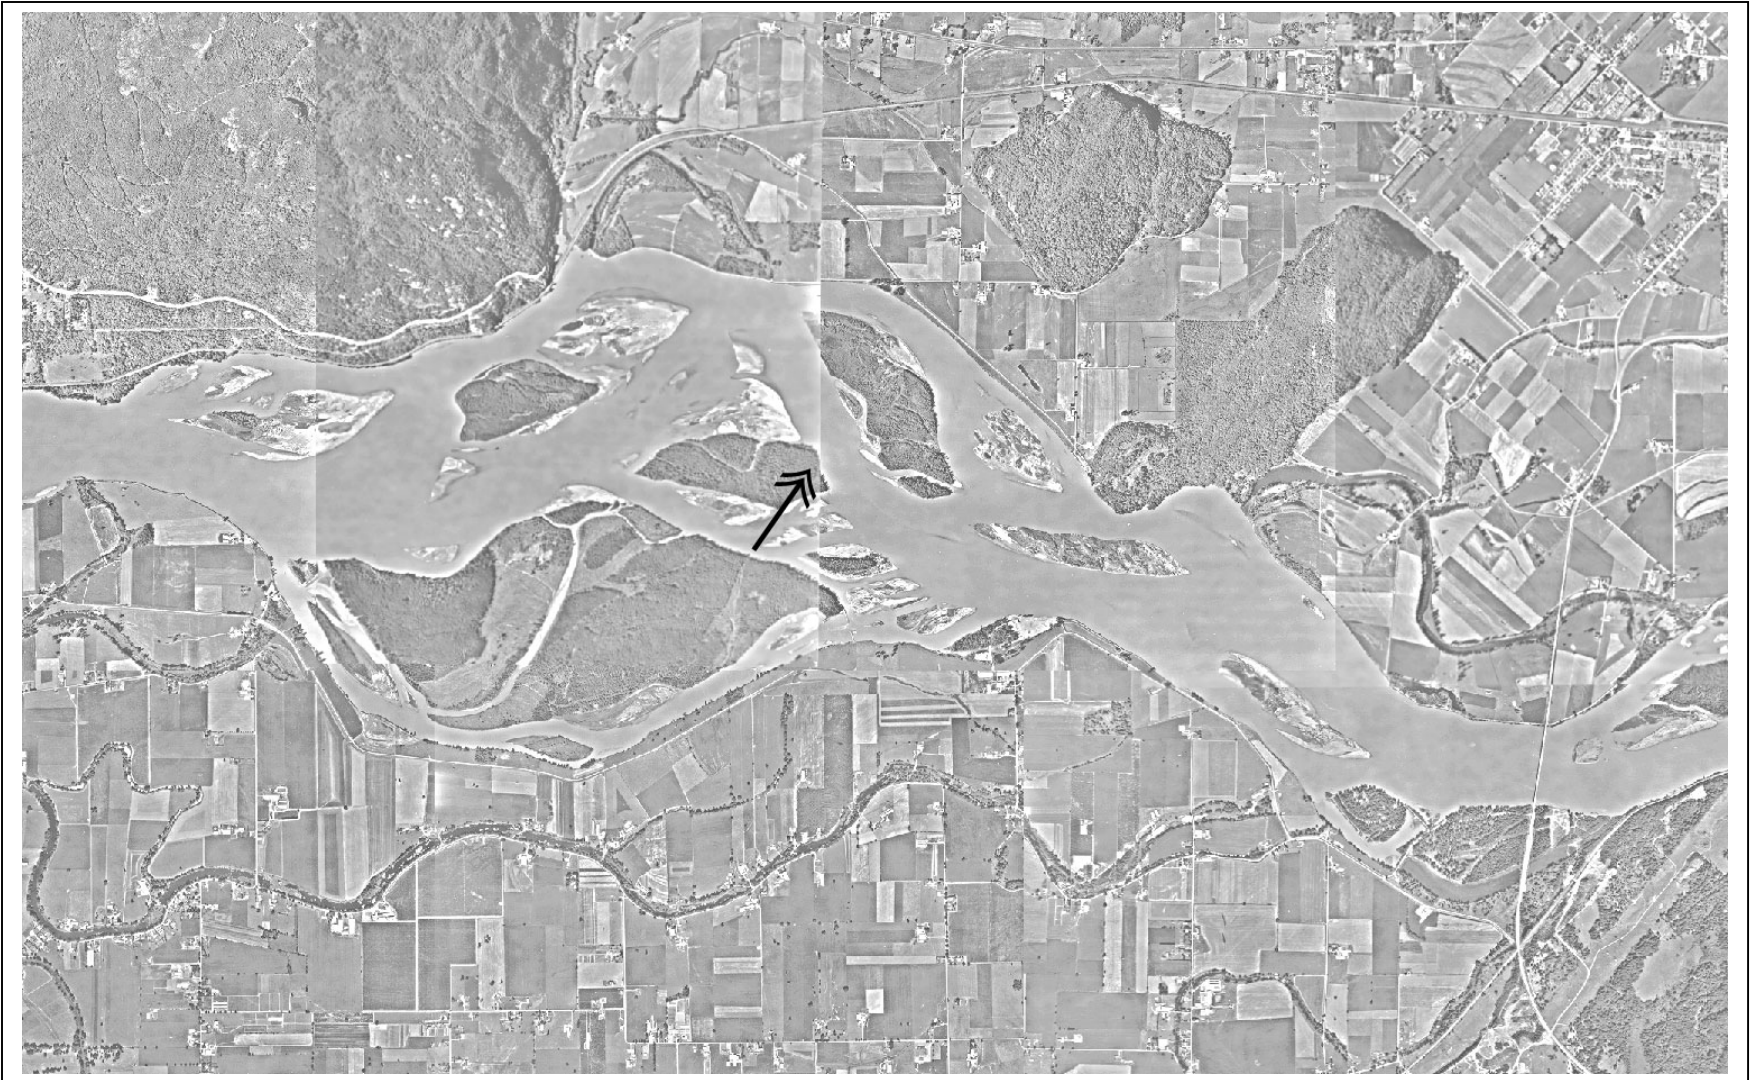
Figure 6 Island 32 and vicinity, July 22, 1983; Hope flow 5,380 m³/s. Source Resource Surveys and Mapping Branch, British Columbia Ministry of Environment, Lands and Parks. Arrows indicate sites of erosional attack.

As the result of channel switching, significant changes continued to occur after 1971. The main changes were within the Gill Island complex and off Mount Woodside. By 1983 vegetation was well established on the now isolated old point bar off Gill Island (in the area presently referred to as Hamilton Bar) as well as on the new bar off Hopyard Hill (Figure 6). As such, the main flow was directed further to the west before being guided to the northwest by the new eastern margin of Gill Island. The net result of these changes was the introduction of an additional bend between Hopyard Hill and the apex of the Gill Island complex. As a result, the strongest currents of the river were now being guided directly against the study site at the meander apex and the right bank channel past Mount Woodside was growing larger.

The same general alignment became more clearly established through the 1980s, with continued deposition and initial vegetation along the margins of the “new” Gill Island point bar (Figure 7). At the relatively high water level shown on the 1983 photography, some of the flow was diverted between Gill Island and the Greyell Island complex and some across Gill Island. Such an alignment would have tended to ease flows along the north bank. Nevertheless, it is likely that Site G-1 would have eroded significantly by this time were it not for the riprap placed along the bank. On the right bank, the old point bar at Gill Island, now a well-wooded island, was becoming incorporated into the sedimentation zone immediately downstream of Hopyard Hill, whilst the upstream portion of that bar – also well vegetated – lay in midstream and was being incorporated into the prograding Big Bar complex. Both of these developments represent switches of the main channel around sediment blocks, so they moved from the vicinity of one bank to the other. A complex, multi-channel river had developed near the study site which, by 1991, effected the closure of the channel across Gill Island and extensive siltation of the channel to the right of Hamilton Bar. As a result, the main channel was directed straight onto the study site.

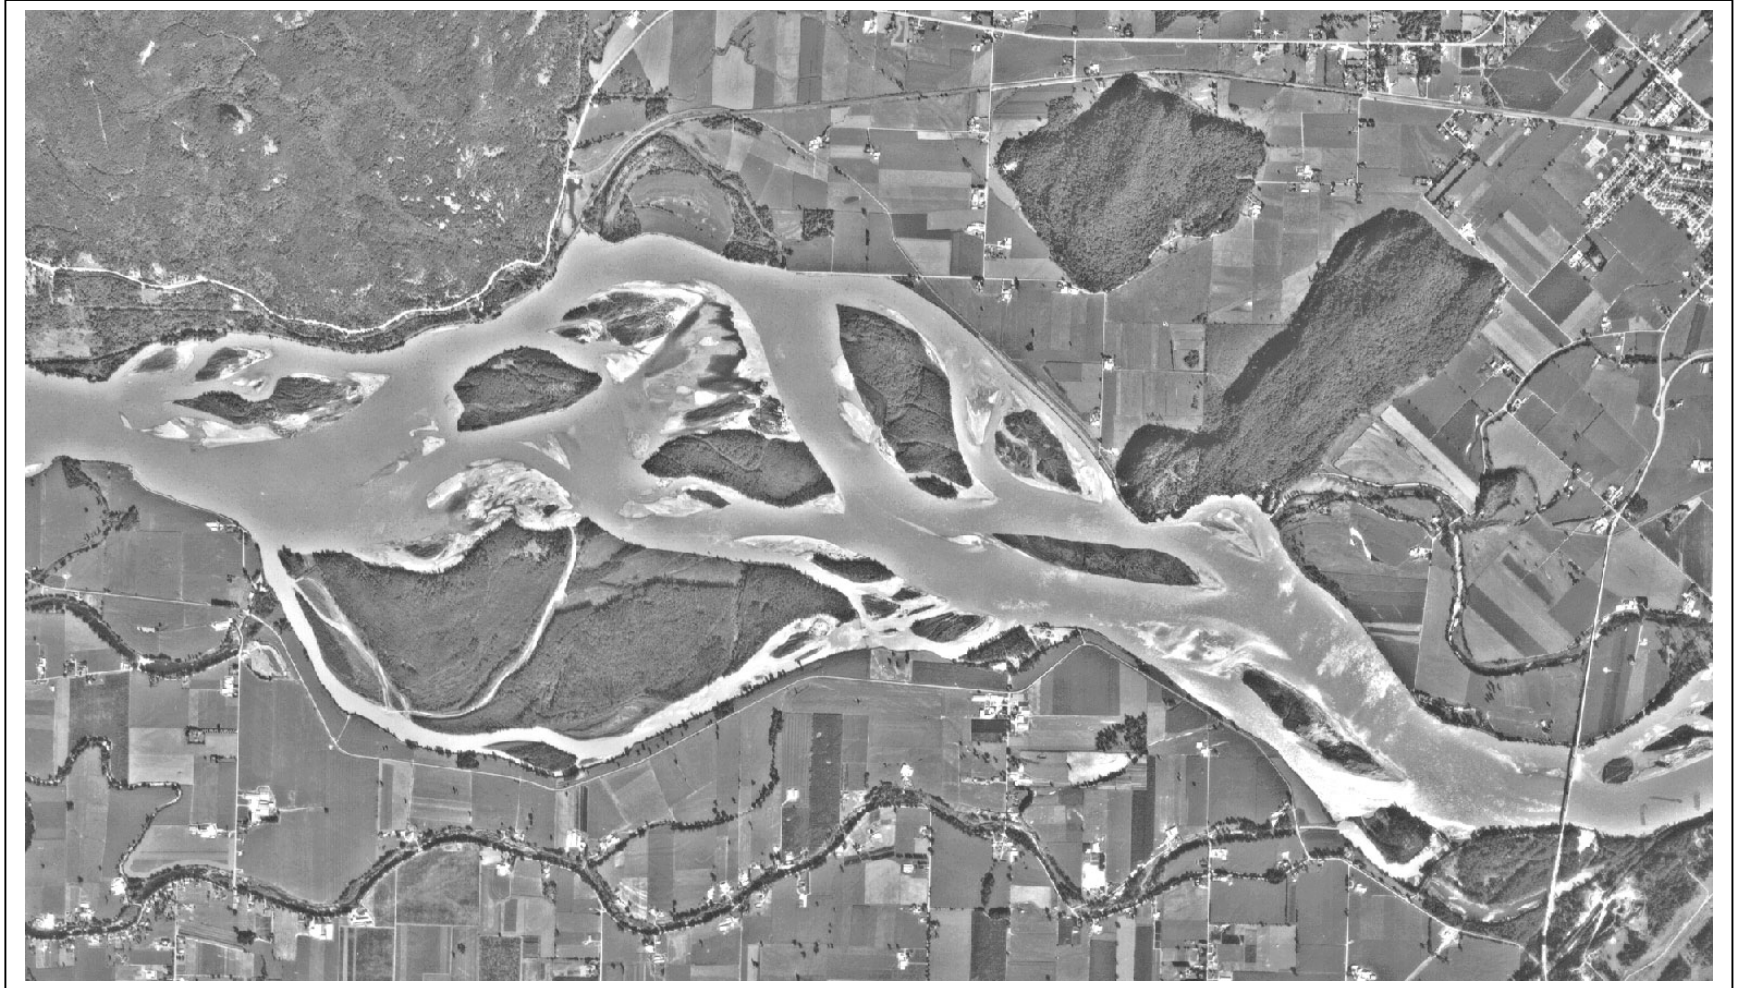
Figure 7 Island 32 and vicinity, September 5, 1991; Hope flow 4,410 m³/s. Source Resource Surveys and Mapping Branch, British Columbia Ministry of Environment, Lands and Parks.
