## **Island 32 Erosion**

prepared for  
Ministry of Environment, Lands and Parks  
10334 152A Street  
Surrey, British Columbia, V3R 7P8

by  
Michael Church and Hamish Weatherly  
Department of Geography  
The University of British Columbia  
Vancouver, British Columbia, V6T 1Z2

November 22, 1999

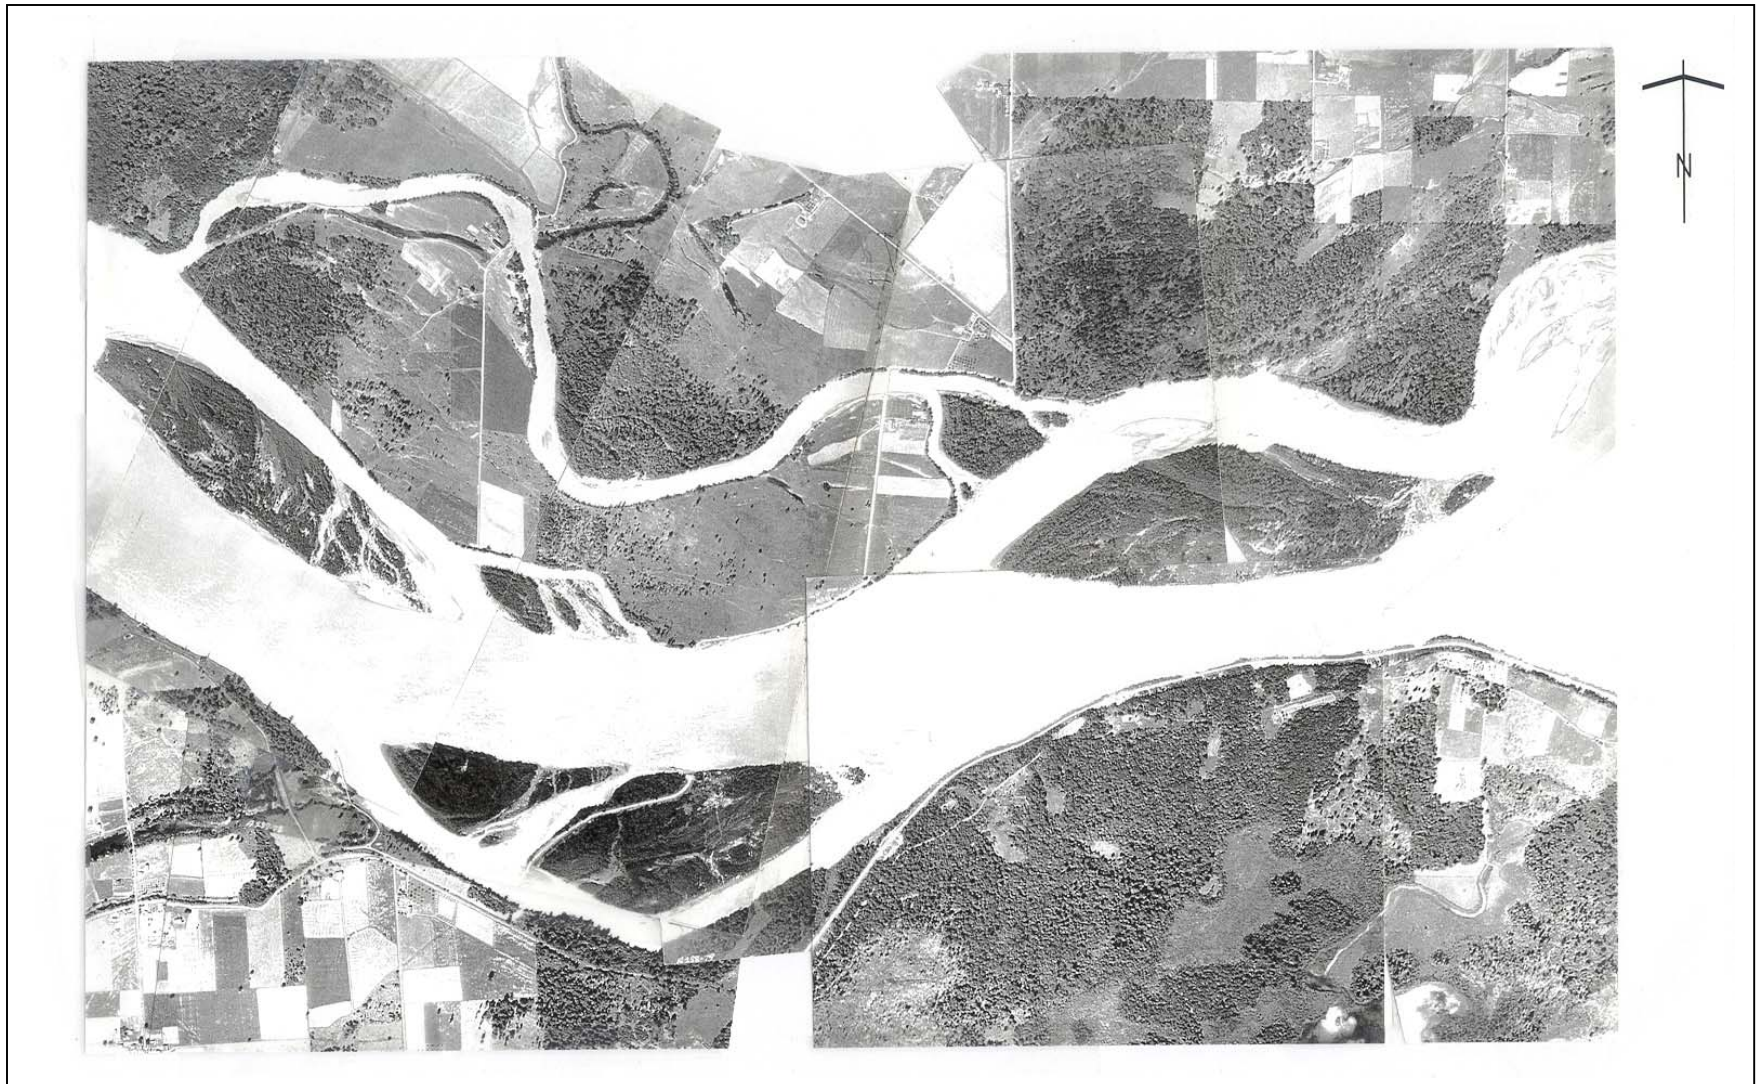
**Figure 2 Island 32 and vicinity, July 15, 1928; Hope flow 5,780 m<sup>3</sup>/s. Airphotos A288-75, 77, 78, 79, 81 and A296-64, 66, 69, 71; source National Air Photo Library, Canada Department of Natural Resources.**

It appears that there is a good chance the erosive tendency will persist on the left bank for some time, and that there is some possibility that the left-hand channel will open up. It is worth noting that, in general, the configuration that could then develop, with a co-dominant or dominant channel on the left bank, is the configuration that existed at this site before 1950 (Figure 2, Figure 3), before Big Bar began to grow.

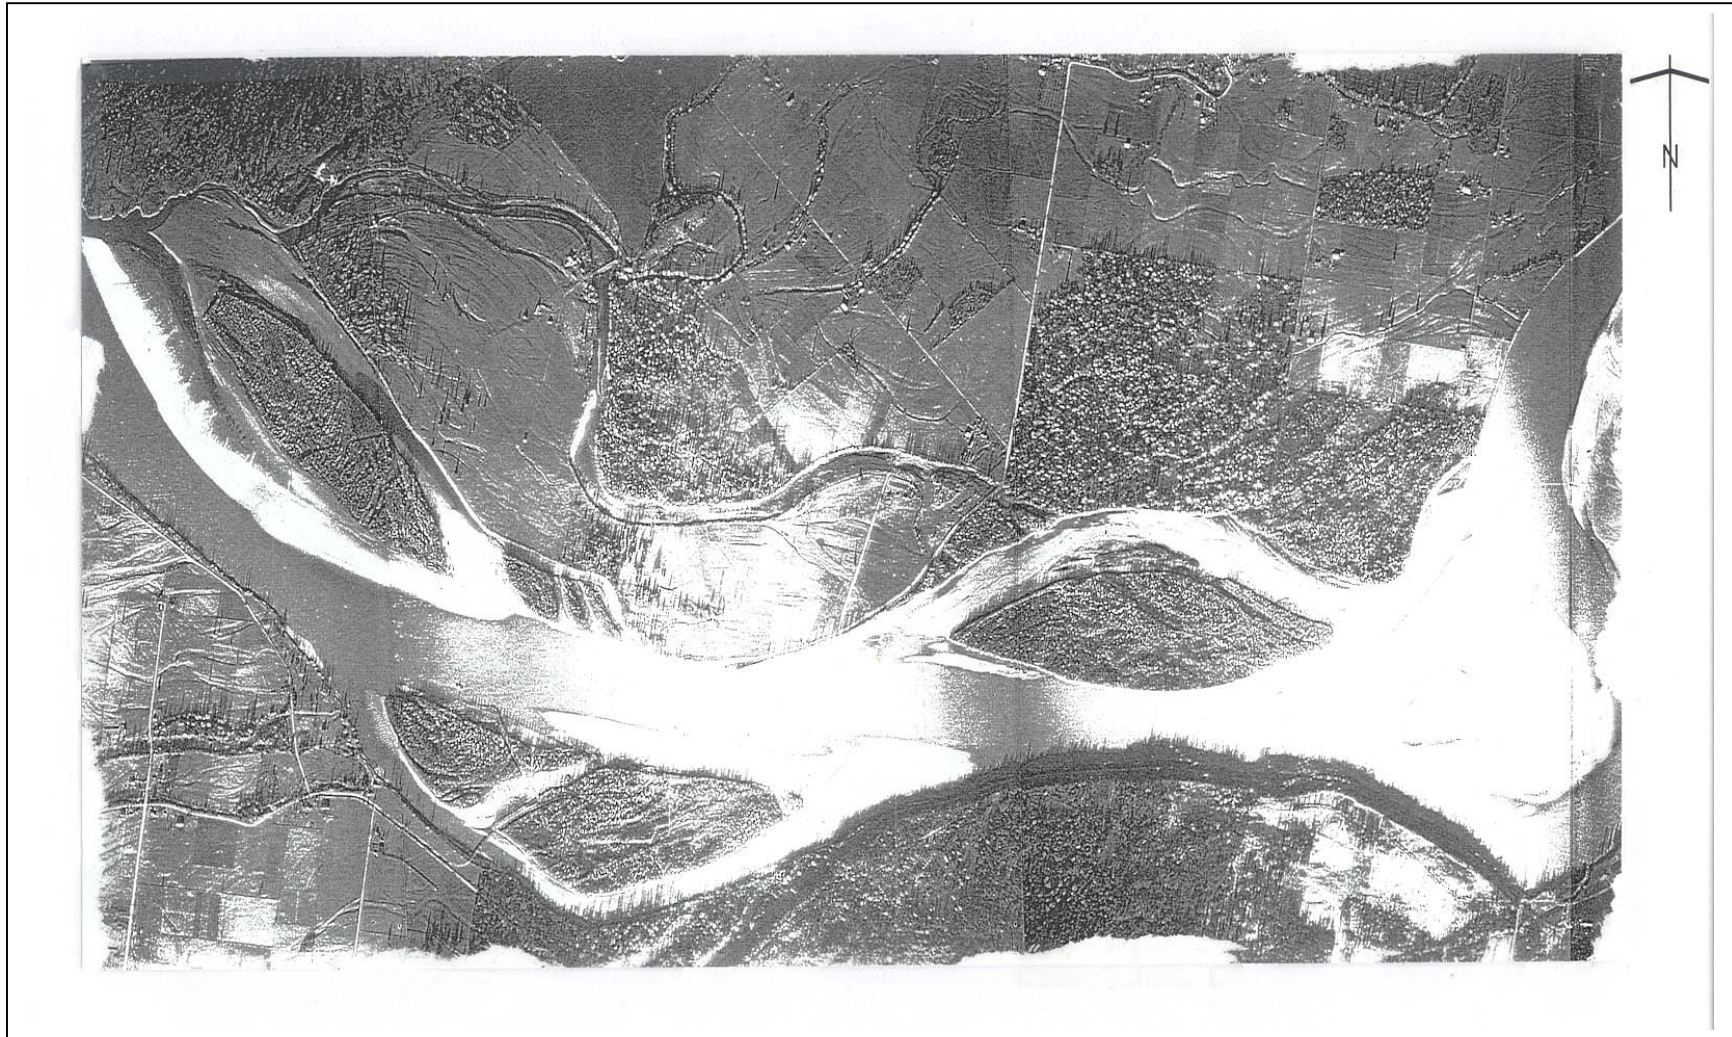
Air photography of December 5, 1943 (Figure 3) reveals a major bar spanning the channel between the upstream end of Powerline Island and the downstream end of the Herrling Island complex. The channel occupied a tortuous bend around this deposit, which brought the main flow against the south side of Powerline Island and confined the majority of flow to the right side

The 1943 photography also reveals a chute across the back of the bar past the entrance to the Powerline Island secondary channel. By 1949, realignment of the main channel along the chute was accomplished (Figure 4). Consequently, flow was directed straight onto the left bank high ground and the Powerline Island backchannel was bypassed. The realignment of the main channel at the Agassiz-Rosedale Bridge back to the left side also had the effect of moving the navigable channel away from the main navigation span built over the north side of the channel. Substantial gravel deposition occurred off the lower end of Powerline Island, along Ferry Island, and on the right bank downstream of Island 32. The Ferry Island back channel appears to have been relatively active and the large bar that developed prior to 1943 is in the initial stages of break-up.

**Figure 3 Island 32 and vicinity, December 4, 1943; Hope flow 533 m<sup>3</sup>/s. Airphotos A7077-7, 9, 11, 13; source National Air Photo Library, Canada Department of Natural Resources.**

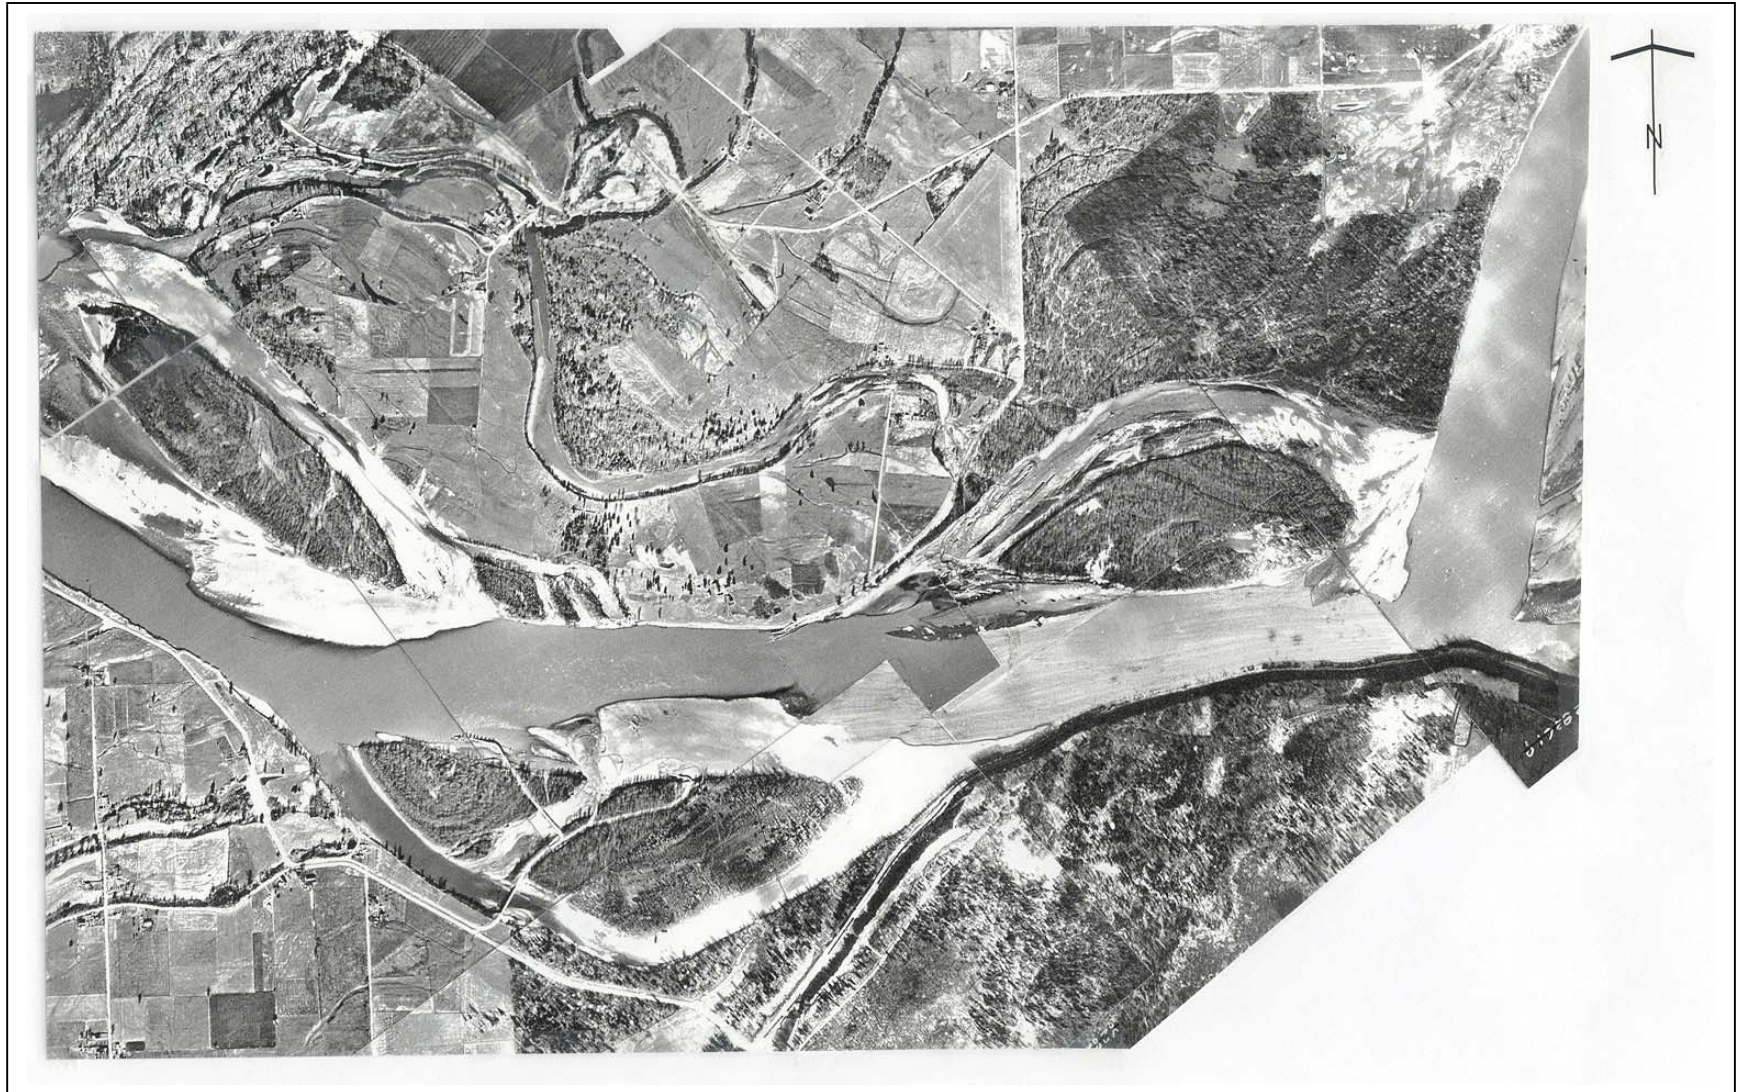
**Figure 4 Island 32 and vicinity, March 23, 1949; Hope flow 733 m<sup>3</sup>/s. Airphotos BC719-23, 24, 114, 116, 118 and BC730-90, 92, 94; source Resource Surveys and Mapping Branch, British Columbia Ministry of Environment, Lands and Parks.**

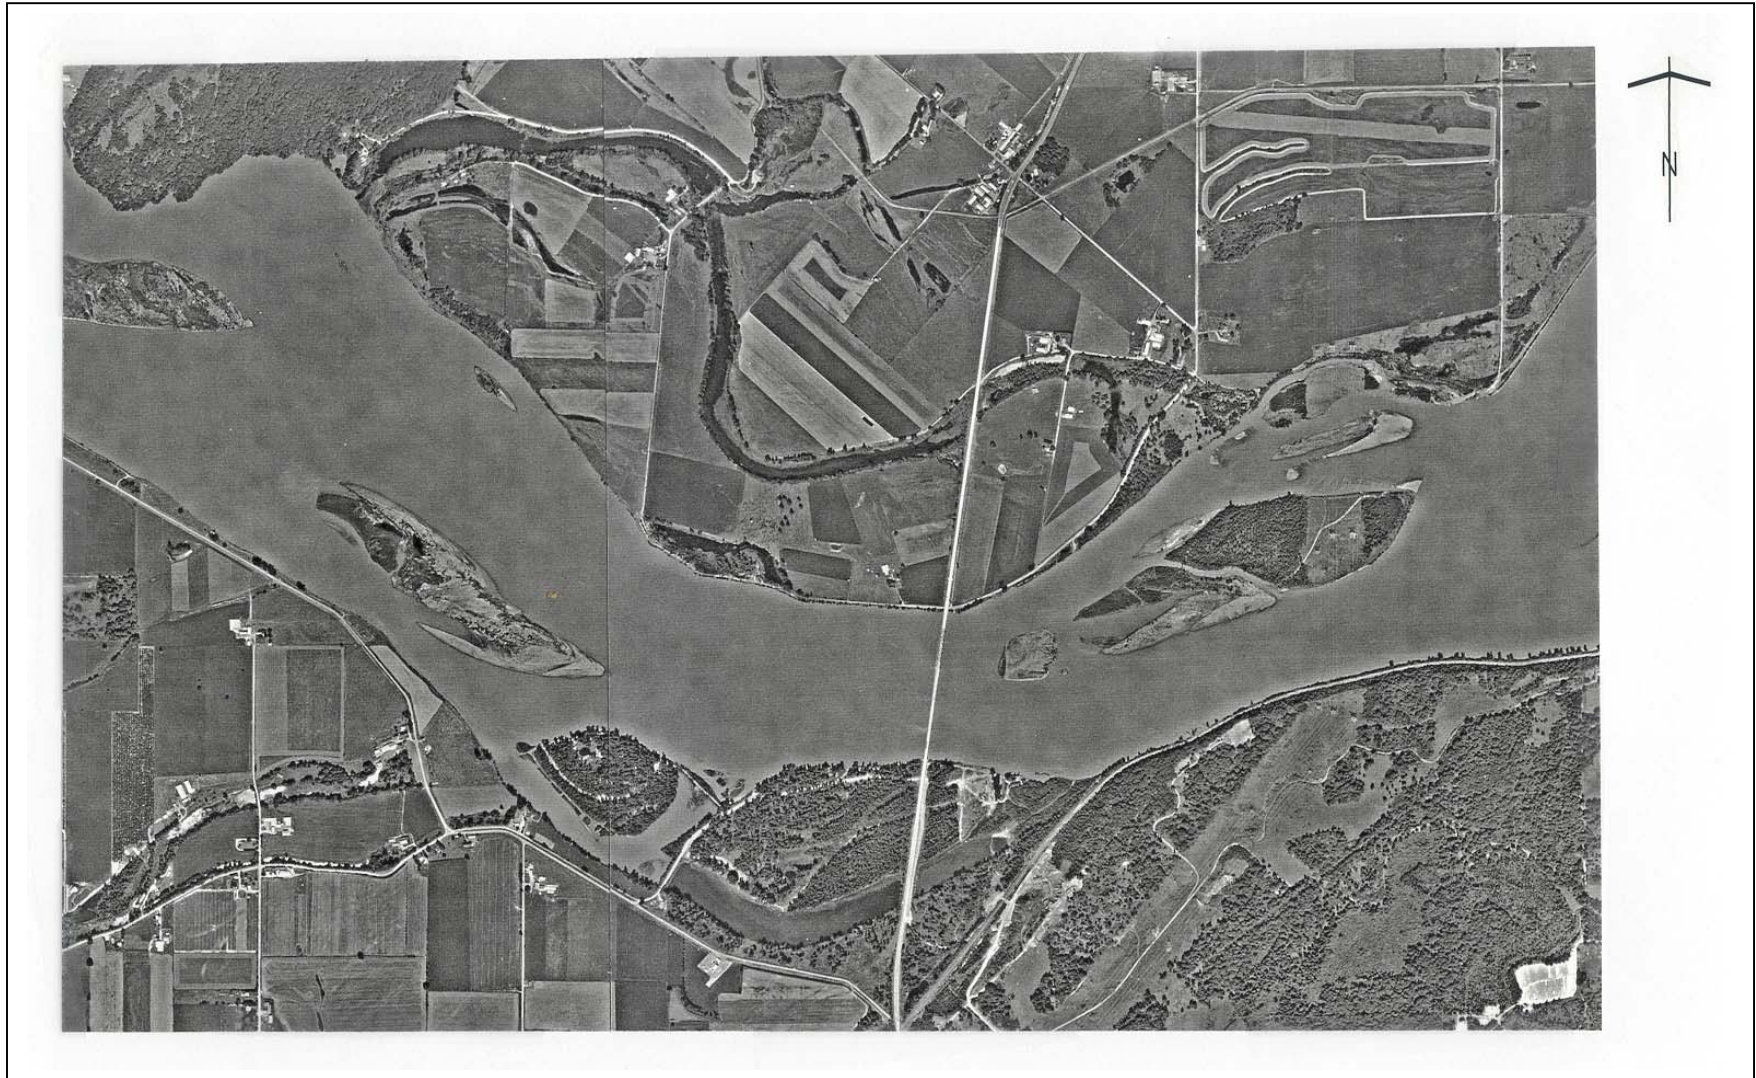
**Figure 7 Island 32 and vicinity, July 22, 1983; Hope flow 5,380 m<sup>3</sup>/s. Airphotos 30BC83012-17, 19; source Resource Surveys and Mapping Branch, British Columbia Ministry of Environment, Lands and Parks.**

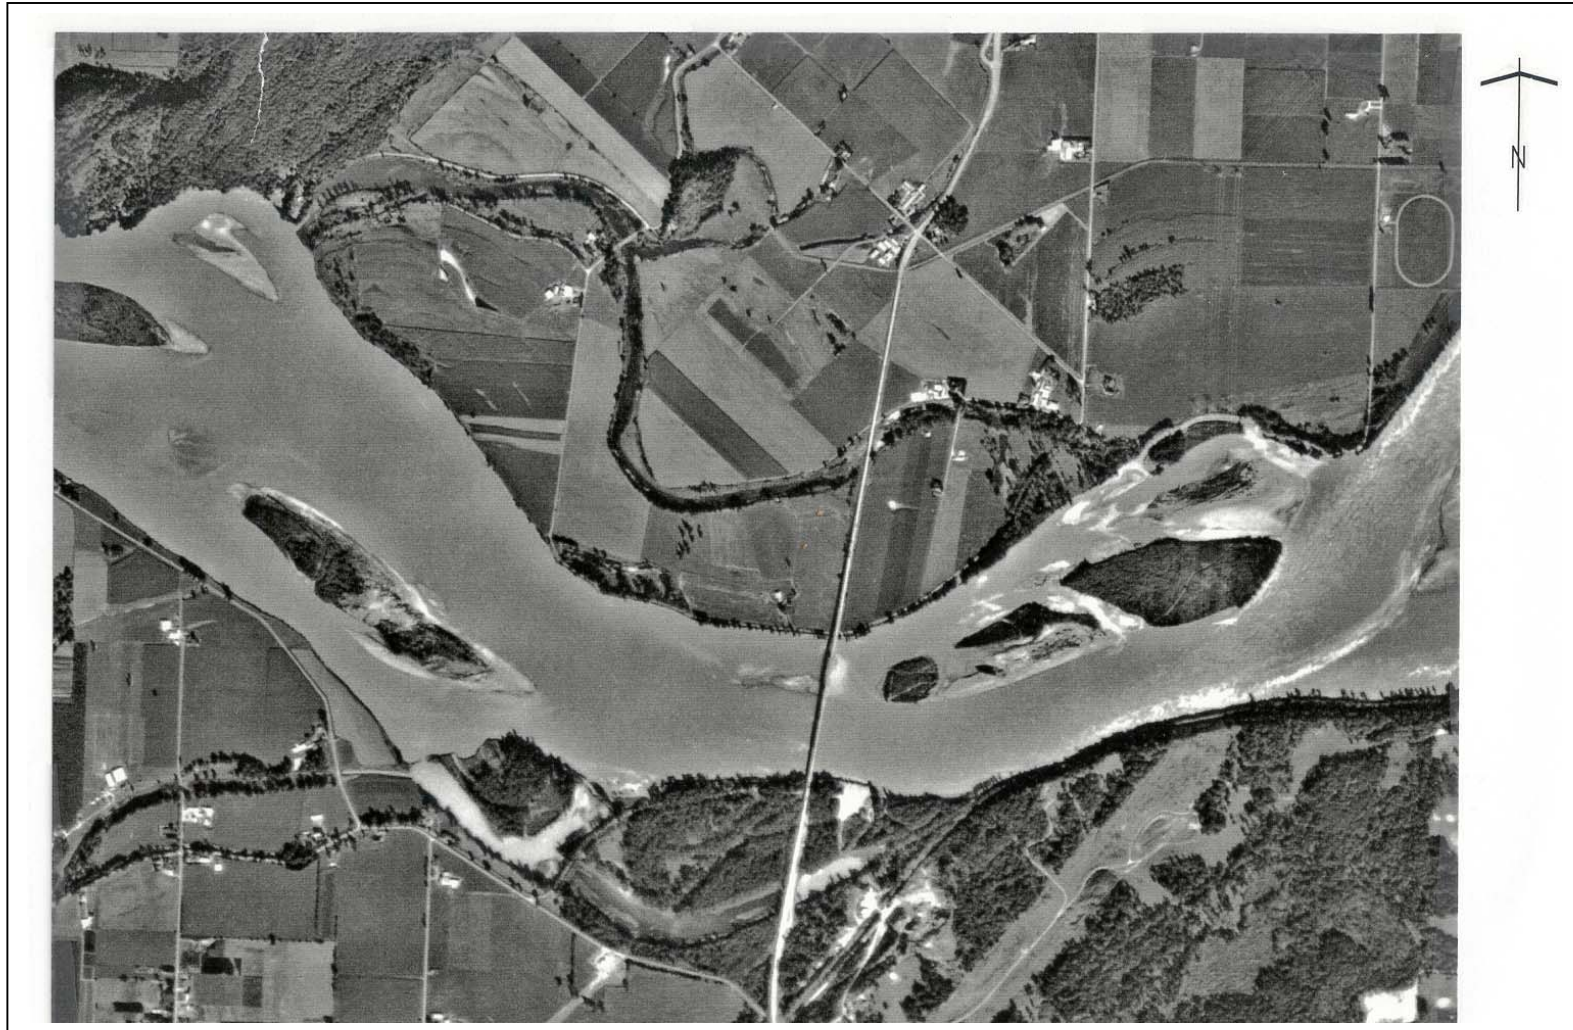
**Figure 8 Island 32 and vicinity, September 5, 1991; Hope flow 4,410 m<sup>3</sup>/s. Airphotos 15BCB91079-66; source Resource Surveys and Mapping Branch, British Columbia Ministry of Environment, Lands and Parks.**

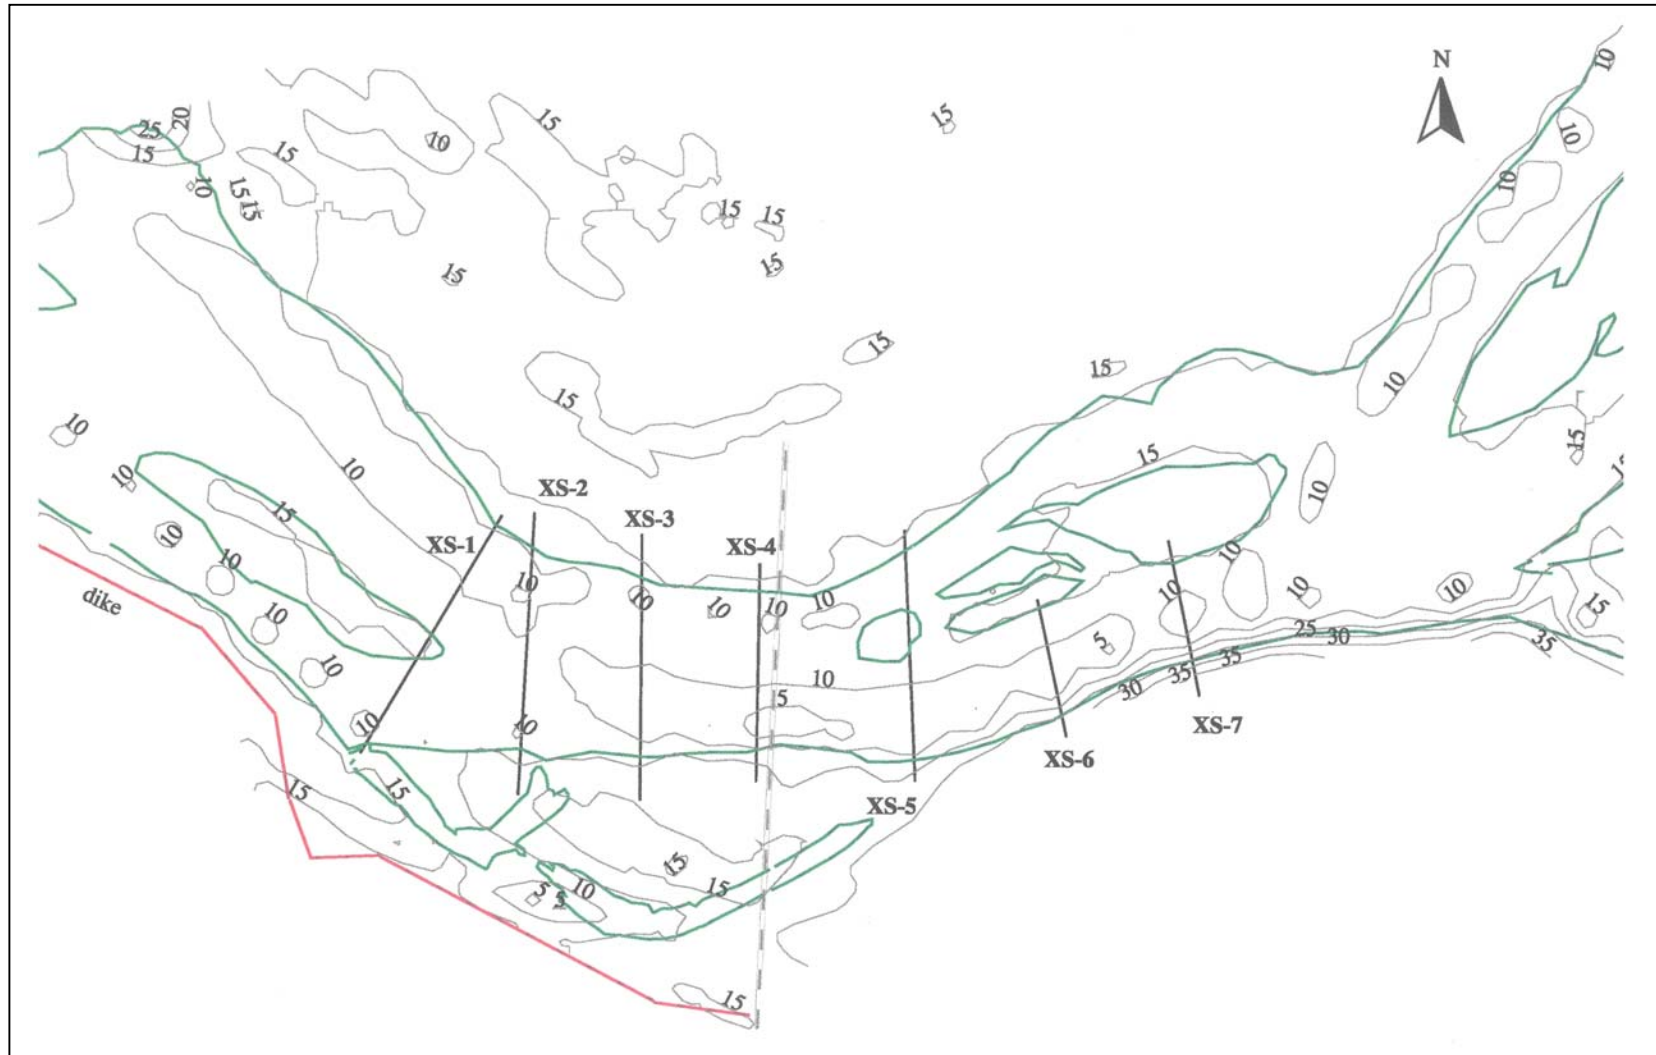
Figure 10 1999 bathymetry of study reach and cross-section locations.

study area (Figure 10) have been constructed from these bathymetric surveys and are shown in Figure 11. Since 1952, there have been few changes in the channel geometry at Powerline Island (cross-sections 6 and 7). Further downstream, however, there is an abrupt shift in the thalweg from the right to the left between 1952 and 1984 (cross-sections 3 and 4), and progressive deepening of the channel to the present. These changes are associated with the migration of the “Ferry Island bar” downstream into Big Bar, development of the Powerline Island bar, and the consequent channel realignment. Furthermore, the entrance to the Ferry Island back channel silted up in the 1970’s and gravel deposition occurred in the Powerline Island back channel. Reduced flow conveyance in these backchannels has increased the high stage constriction of flow in the main channel. At cross-sections 1 and 2, off Island 32, the thalweg continues to be on the right bank but, following the construction of Big Bar after 1950, the channel remains divided, and there is significant degradation in the left hand channel, which flows between Big Bar and the left bank.
